# Fire Risk Assessment

Carried out on behalf of  
Hazelwood Nursery & Early Years School  
On the  
22 Oct 2025  
By  
Ian Meares AIFireE

Hazelwood Nursery & Early Years School  
19 Bluehouse Lane Oxted Surrey  
RH8 0QU

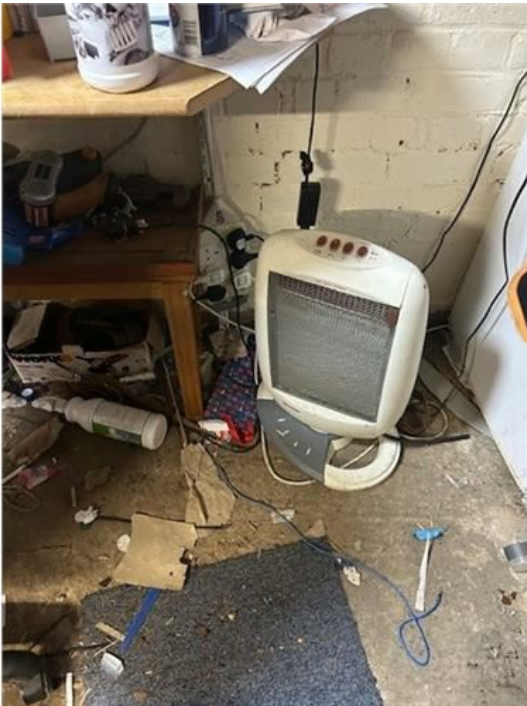
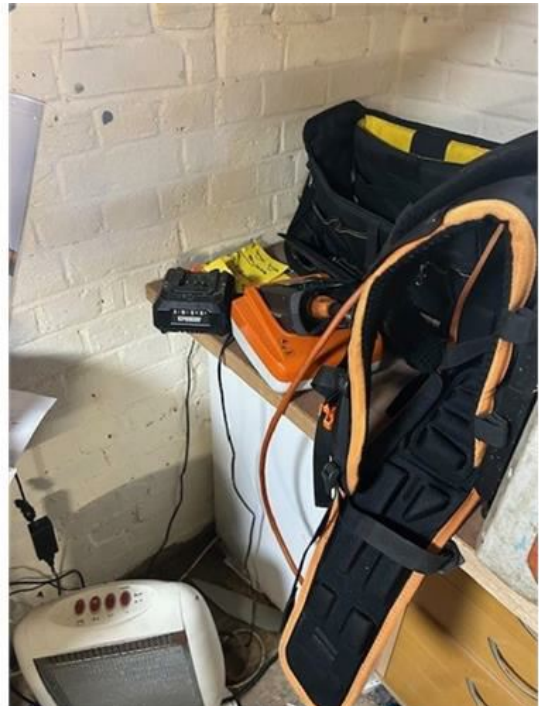
Hazel Orchard overloading of adapter.jpg

| Sub Section | Question | Answer | Action Plan | Status |
|---|---|---|---|---|
| <b>02 - Electrical Services</b> | Are all electrical installations and appliances correctly installed and maintained? | There is unsafe use of multi point adapters. | <a href="#">2.0.H</a> | <b>Non_Compliant</b> |

| Ref | Sub Section | Question | Non-conformity | Recommendation | Location | Who is responsible | By When |
|---|---|---|---|---|---|---|---|
| 13704986 | 2.0.H | Are all electrical installations and appliances correctly installed and maintained? | There is unsafe use of multi point adapters. | These appliances are to be removed from the workplace and additional power sockets provided in this area. | Orchard workshop | Recommendation to the Client | 18/12/2025 |

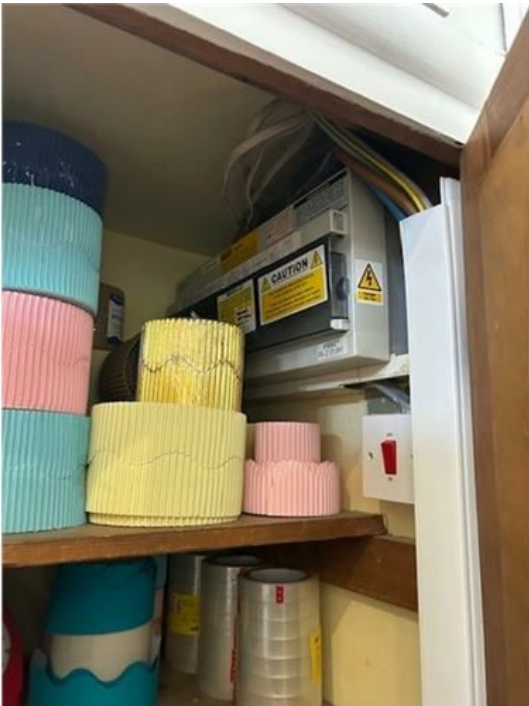
Hazel Orchard reception combustibles near consumer board.jpg

| Ref | Sub Section | Question | Non-conformity | Recommendation | Location | Who is responsible | By When |
|---|---|---|---|---|---|---|---|
| 13704988 | 2.0.NR-46-177-10 | Are all electrical installations and appliances correctly installed and maintained? | Combustible materials are sited close to the consumer box within the reception cupboard. | Remove the combustible materials away from the consumer board | Reception office cupboard | Recommendation to the Client | 18/12/2025 |

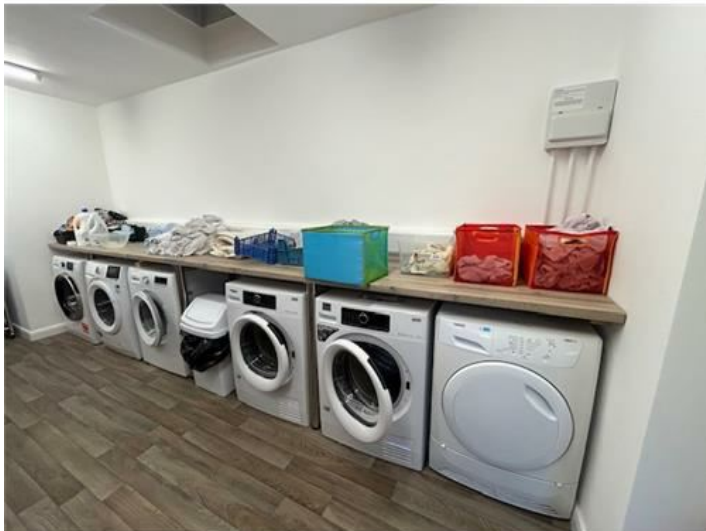
Hazel Orchard laundry no Override turn off switch.jpg

| Ref | Sub Section | Question | Non-conformity | Recommendation | Location | Who is responsible | By When |
|---|---|---|---|---|---|---|---|
| 13704987 | 2.0.NR-46-177-9 | Are all electrical installations and appliances correctly installed and maintained? | The laundry room contains six machines, all of which are powered by their own individual plug and socket. There is no power-off switch to turn off the power in an emergency. | Install a power off switch externally to the laundry room. | Laundry room | Recommendation to the Client | 18/12/2025 |

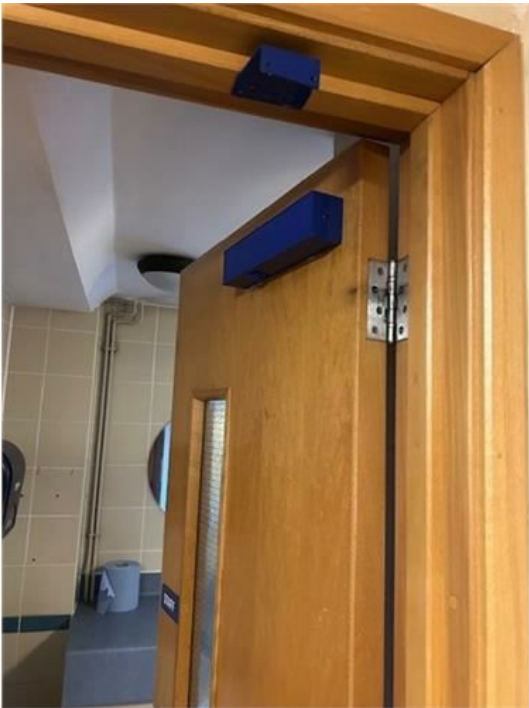
Hazel Forest door closer broke.jpg

| Sub Section | Question | Answer | Action Plan | Status |
|---|---|---|---|---|
| <b>11 - Fire-resisting doors</b> | Do the fire resisting door sets meet the appropriate standard? | Ineffective self closing devices. The device is broken. | <a href="#">5.0.1</a> | <b>Non_Compliant</b> |

| Ref | Sub Section | Question | Non-conformity | Recommendation | Location | Who is responsible | By When |
|---|---|---|---|---|---|---|---|
| 13704992 | 5.0.J | Do the fire resisting door sets meet the appropriate standard? | Ineffective self closing devices. The device is broken. | Repair or replace the self-closing device/s to ensure fire door/s close fully into their frame/s against the door stops. | Door from adult toilet onto escape stairs | Statutory requirement for the Client | 18/12/2025 |

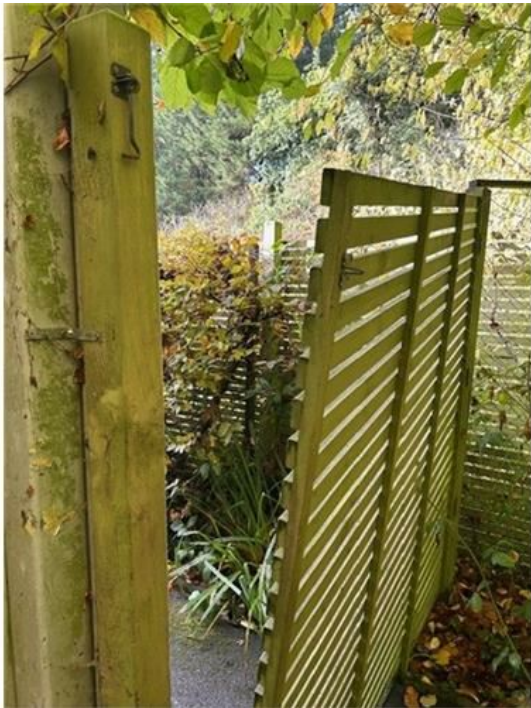
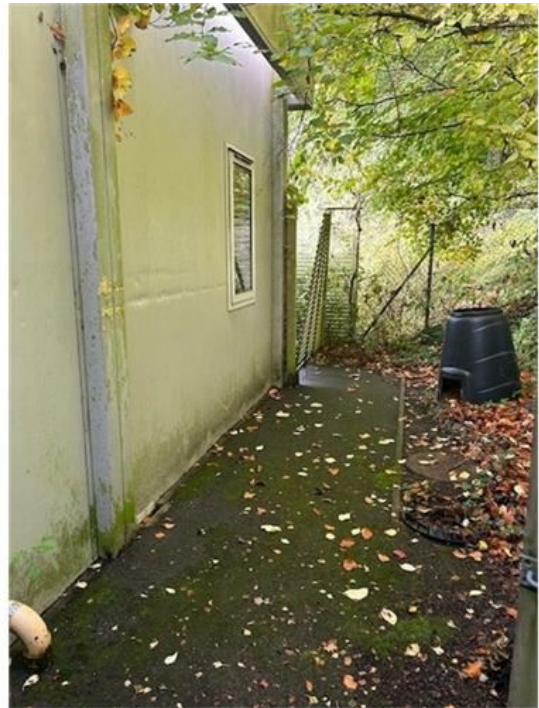
Hazel Elm Escape route gate replaced.jpg

| Ref | Sub Section | Question | Non-conformity | Recommendation | Location | Who is responsible | By When |
|---|---|---|---|---|---|---|---|
| 13704996 | 5.0.NR-49-201-2 | Are house keeping arrangements satisfactory? | The Escape route from the rear of Elm kitchen is via a wooden gate that has feel of its hinge and is difficult to open. | The gate should be repaired or replaced so it opens easily. | Rear gate | Statutory requirement for the Client | 18/12/2025 |

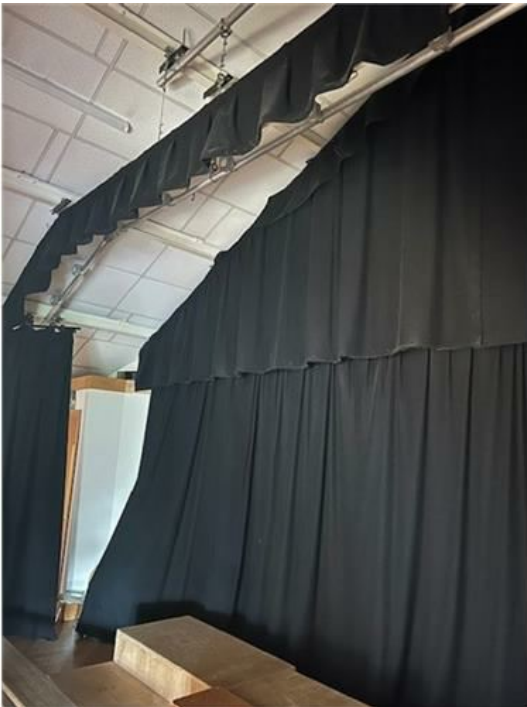
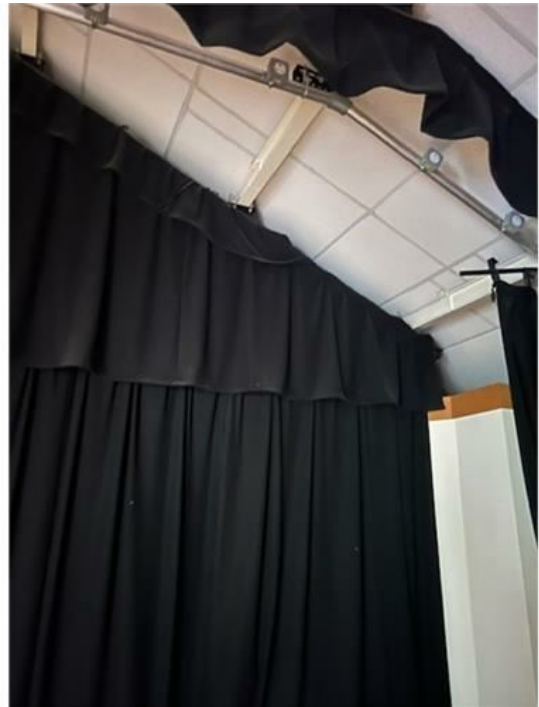
Hazel Forest stage curtains.jpg

| Ref | Sub Section | Question | Non-conformity | Recommendation | Location | Who is responsible | By When |
|---|---|---|---|---|---|---|---|
| 13704989 | B | Are the materials used to line walls and ceilings of the correct surface spread of flame classification in accordance with the Approved Document B of the Building Regulations? | Circulation spaces and corridors have been lined with materials that will contribute significantly to the spread of flame across their surface. | Confirm that an approved treatment has been applied to provide a class 0 surface spread of flame, as per our conversation or apply an approved treatment that provides the same rating. | Patterson Hall | Recommendation for Client | 18/12/2025 |

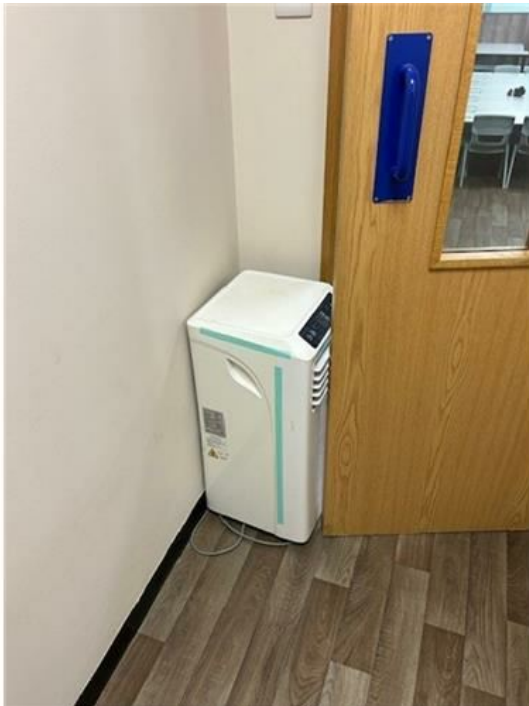
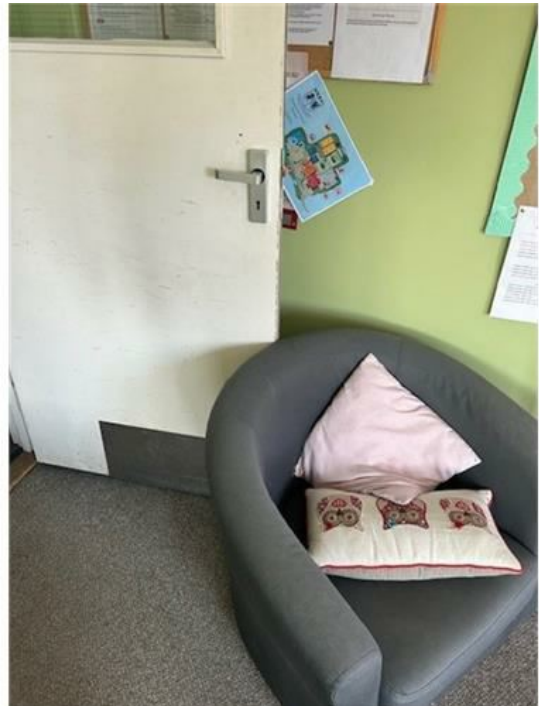
Hazel Elm FD blocked by Air Con blower.jpg

| Ref | Sub Section | Question | Non-conformity | Recommendation | Location | Who is responsible | By When |
|---|---|---|---|---|---|---|---|
| 13704994 | D | Are house keeping arrangements satisfactory? | The Fire Door on the escape route is obstructed. 1- Door in Elm Dining room 2- Door in Orchard staff room | The items obstructing the escape route must be removed. | Door from dining area to rear escape | Recommendation for Client | 18/12/2025 |

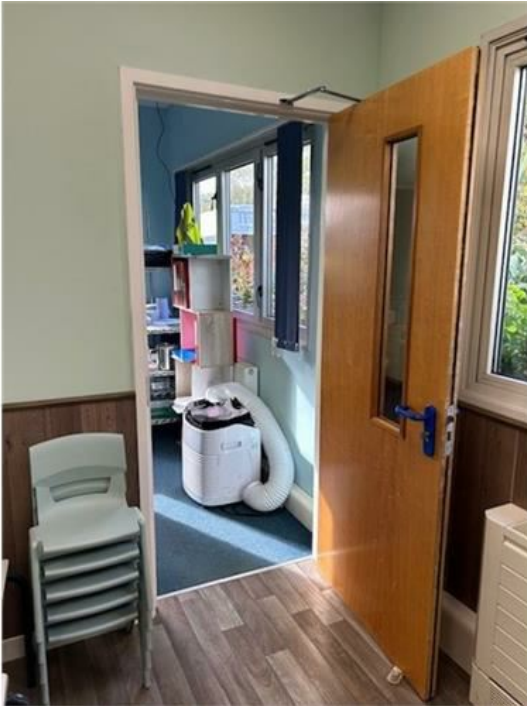
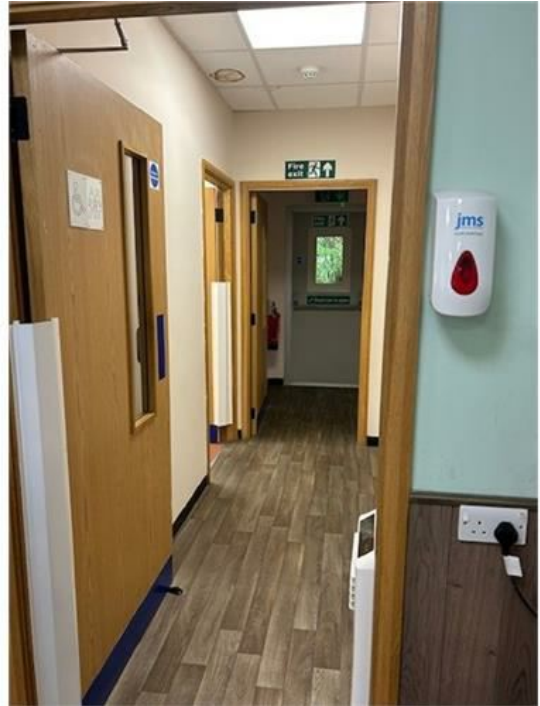
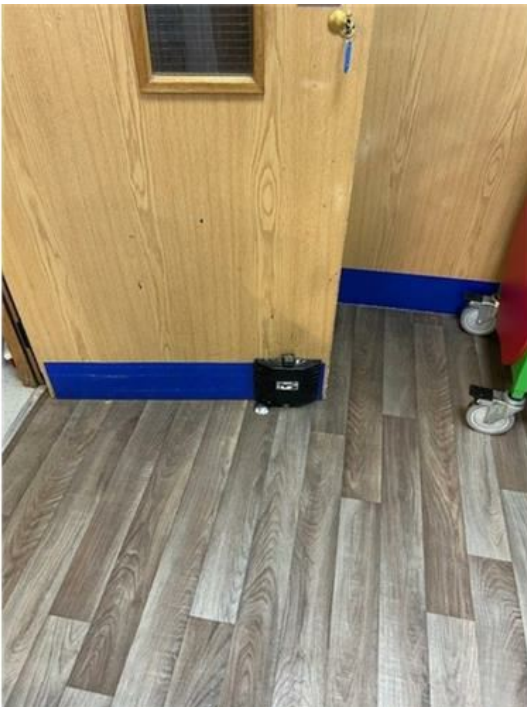
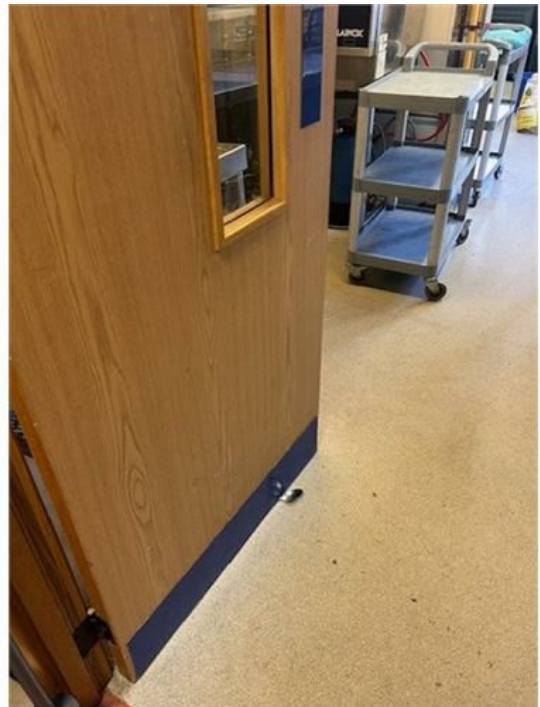
Hazel Elm wedge.jpg

| Sub Section | Question | Answer | Action Plan | Status |
|---|---|---|---|---|
| <b>11 - Fire-resisting doors</b> | Do the fire resisting door sets meet the appropriate standard? | Fire doors were found to be wedged open using bent spoons. | <a href="#">G</a> | <b>Non_Compliant</b> |

| Ref | Sub Section | Question | Non-conformity | Recommendation | Location | Who is responsible | By When |
|---|---|---|---|---|---|---|---|
| 13704991 | G | Do the fire resisting door sets meet the appropriate standard? | Fire doors were found to be wedged open using bent spoons. | Remove the wedges from doors and maintain closed when not in use, this identifies a training need as staff do not understand the essential role of the fire door. If this door requires to be held open, an approved automatic hold open/release device can be installed as an acceptable alternative. Installation must be completed by a competent person in accordance with BS EN 1155 or BS 5839-3. | Various doors around the kitchen and dining room. | Recommendation for Client | 18/12/2025 |

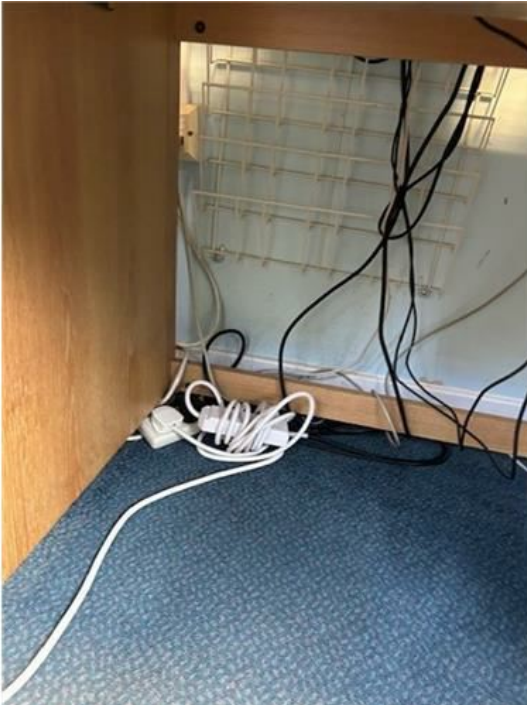
Hazel Elm Daisy chaining.jpg

| Ref | Sub Section | Question | Non-conformity | Recommendation | Location | Who is responsible | By When |
|---|---|---|---|---|---|---|---|
| 13704985 | I | Are all electrical installations and appliances correctly installed and maintained? | The use of extension leads is not adequately controlled. Extension leads should not be connected together, this is known as 'daisy chaining'. | These appliances are to be used in accordance with manufacturers' instructions or alternatively, additional power sockets provided in this area. | Elm Kitchen | Recommendation for Client | 18/12/2025 |

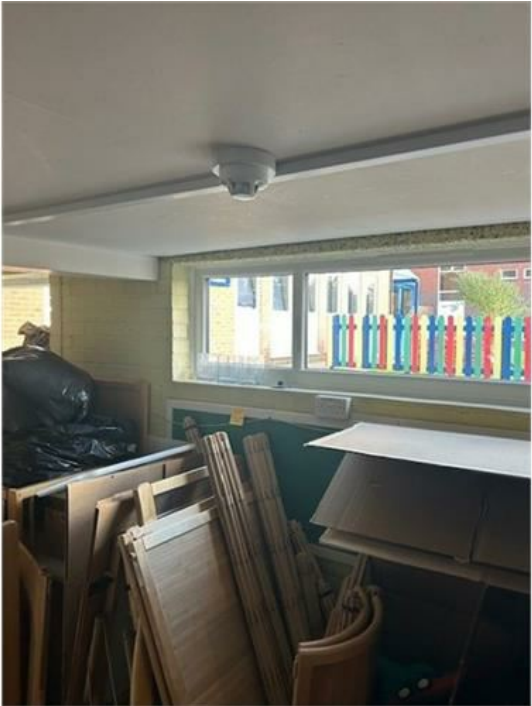
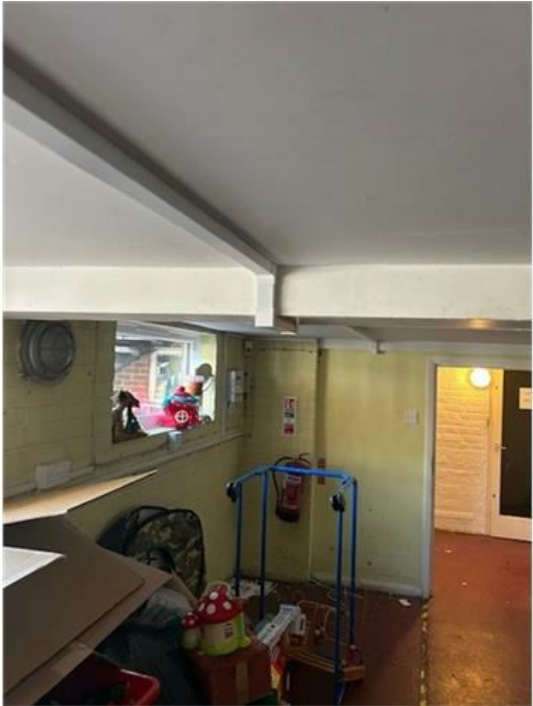
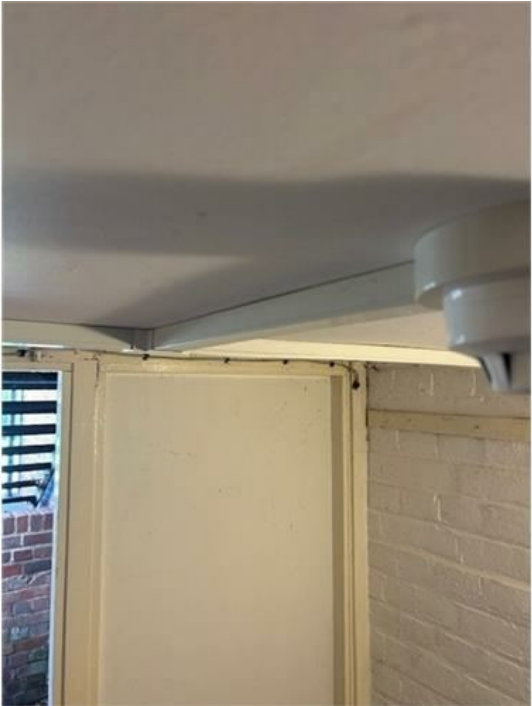
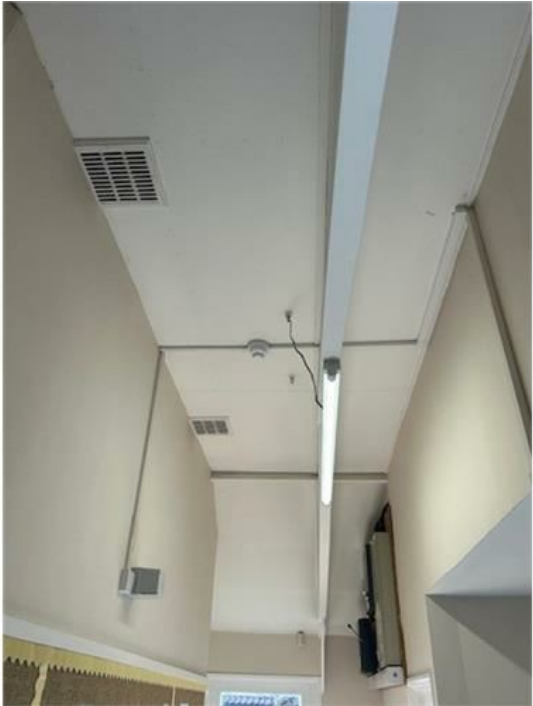
Hazel Orchard trunking.jpg

| Sub Section | Question | Answer | Action Plan | Status |
|---|---|---|---|---|
| <b>02 - Firefighter Safety</b> | Have all reasonable measures and arrangements been made to safeguard firefighting personnel in a fire situation? | A large number of overhead cables are being supported by plastic cable-ties or plastic trunking, this can lead to fire-fighter fatalities as they fail and cables drop in a fire situation. | <a href="#">E</a> | <b>Non_Compliant</b> |

| Ref | Sub Section | Question | Non-conformity | Recommendation | Location | Who is responsible | By When |
|---|---|---|---|---|---|---|---|
| 13705001 | E | Have all reasonable measures and arrangements been made to safeguard firefighting personnel in a fire situation? | A large number of overhead cables are being supported by plastic cable-ties or plastic trunking, this can lead to fire-fighter fatalities as they fail and cables drop in a fire situation. | A competent person is to survey all electrical cabling throughout the premises and the cabling secured with fastening devices to ensure failure will not occur within the early stages of a fire. | Orchard building throughout | Recommendation for Client | 16/02/2026 |
