# Fire Risk Assessment

Hazelwood School

21 Oct 2025

Ian Meares AIFireE

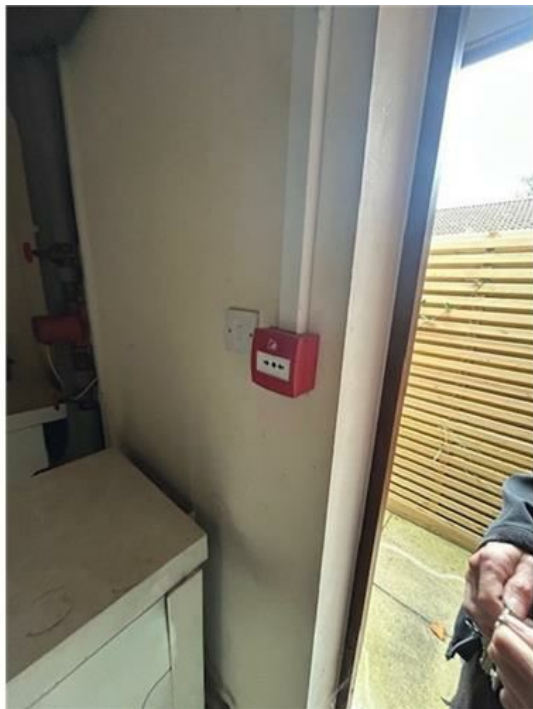
Hazel Ruth no MCP in plant room.jpg

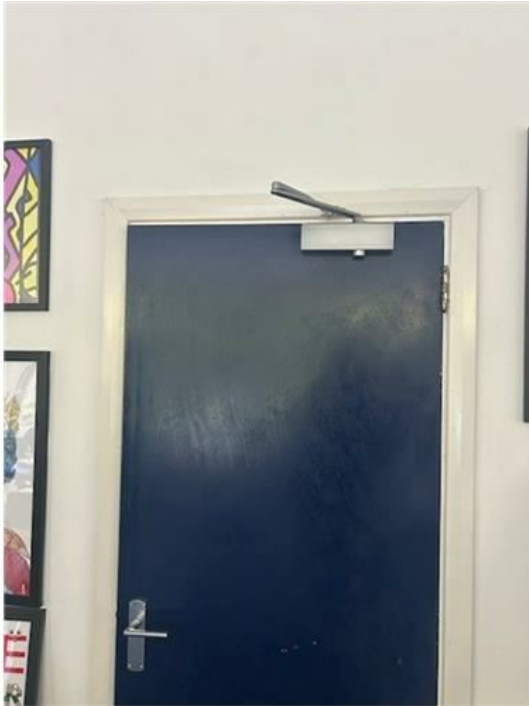
Hazel Dining door to exit rout not identified.jpg

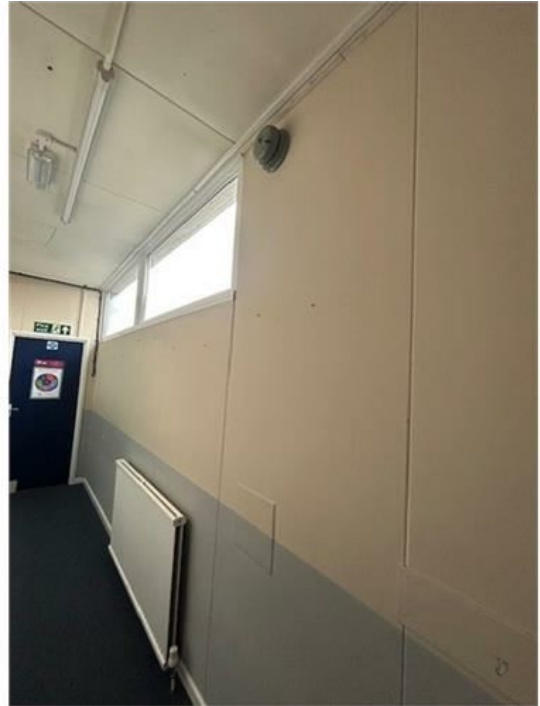
Hazel Dining sign required on the wall -two way corridor..jpg

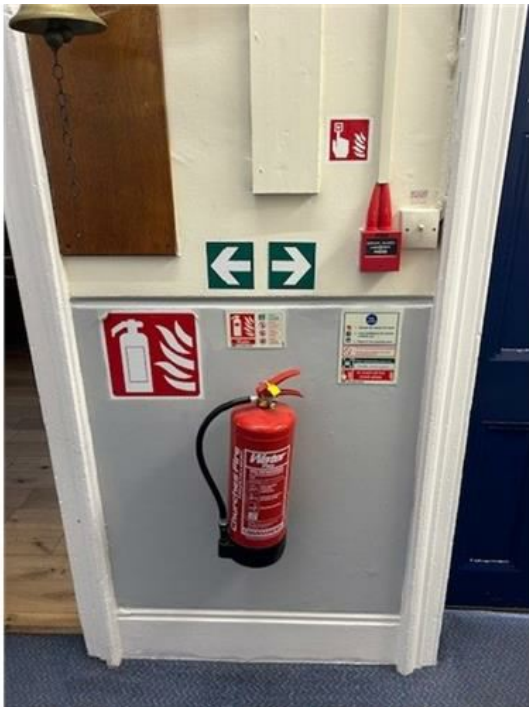
Hazel Main Incorrect signage.jpg

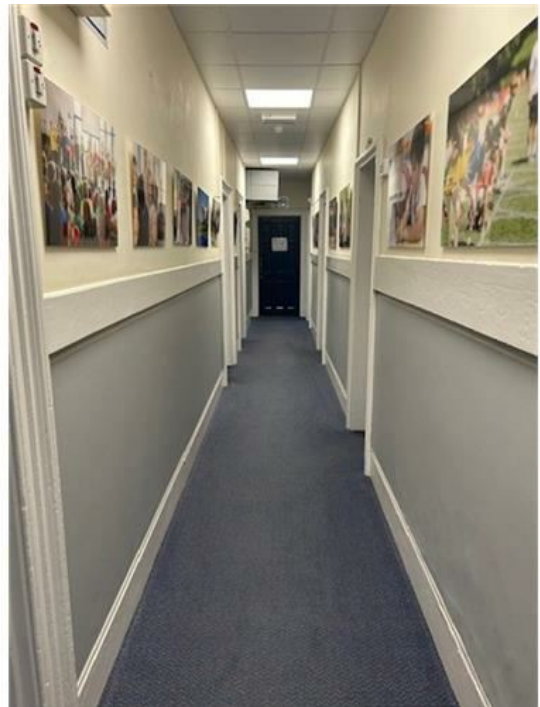
Hazel Main no signage.jpg

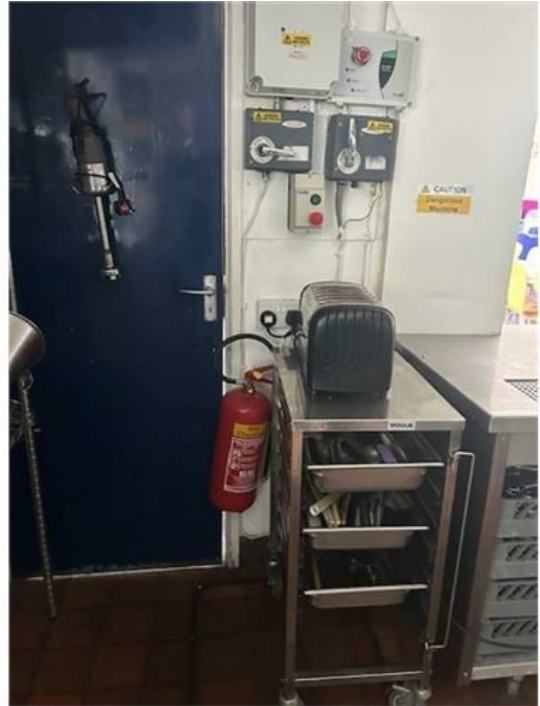
Hazel Dining extinguisher and sign obstructed.jpg

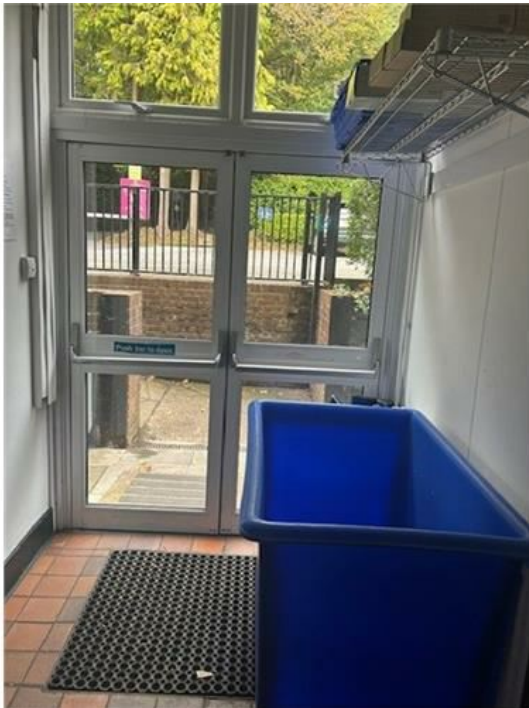
Hazel Dining no push bar.jpg

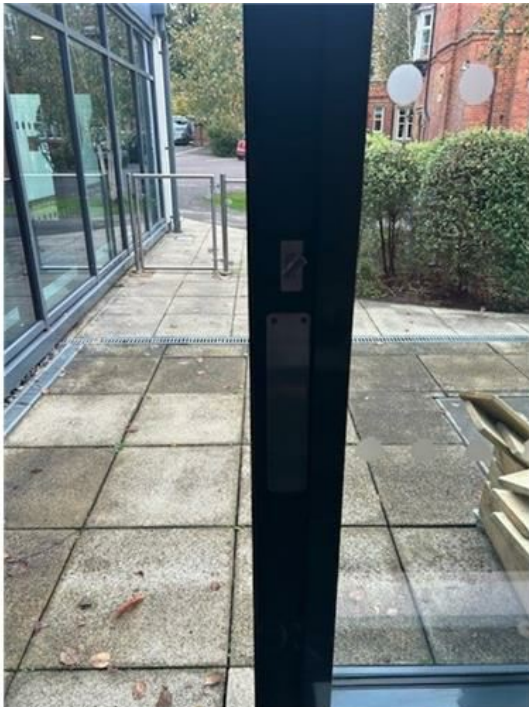
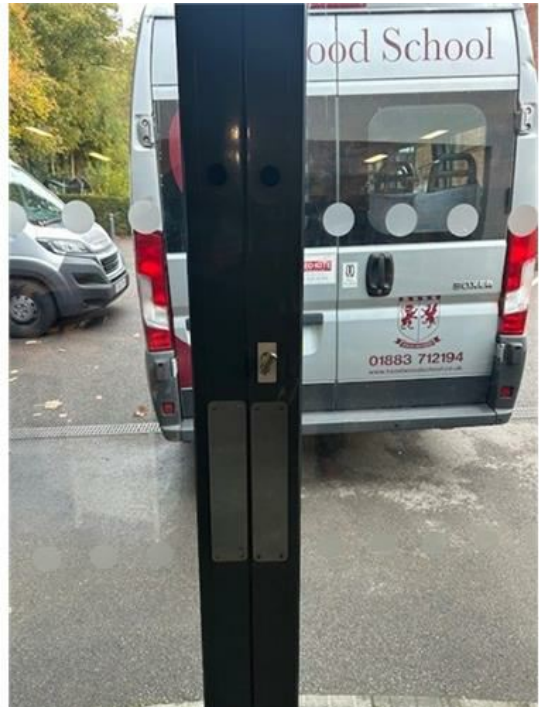
Hazel Bailey No sign for opening device.jpg

Hazel Bailey No sign for opening device 2.jpg

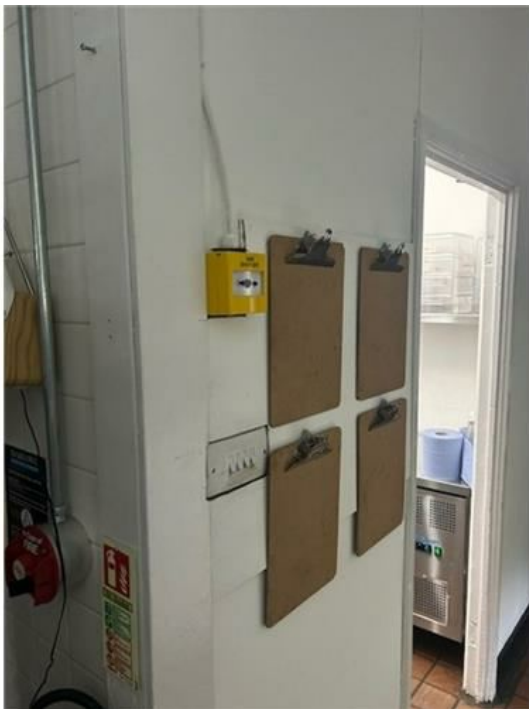
Hazel Dining No STOP sign.jpg

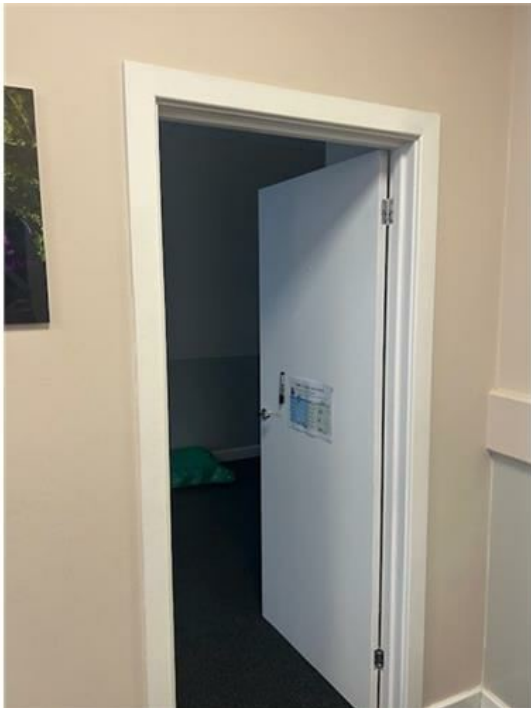
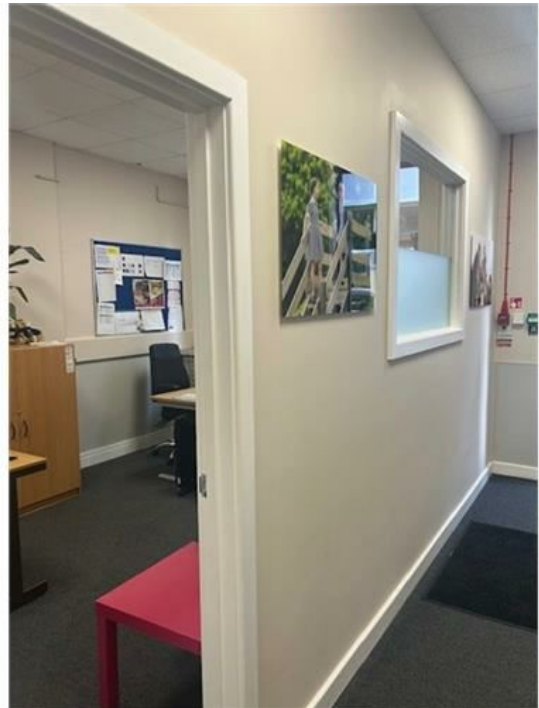
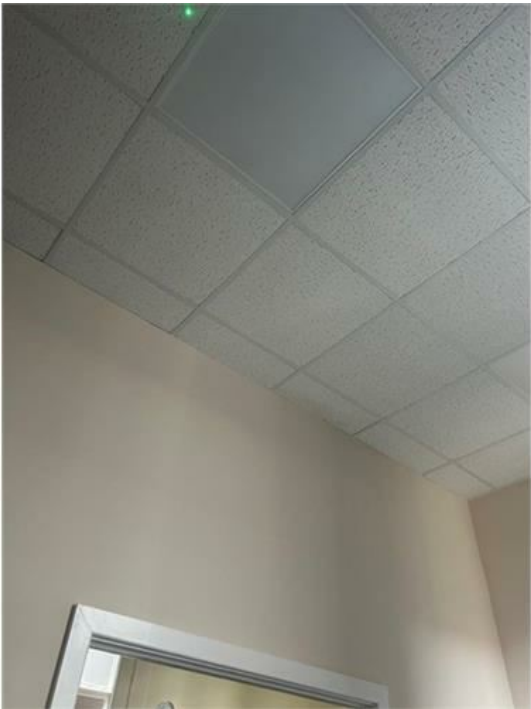
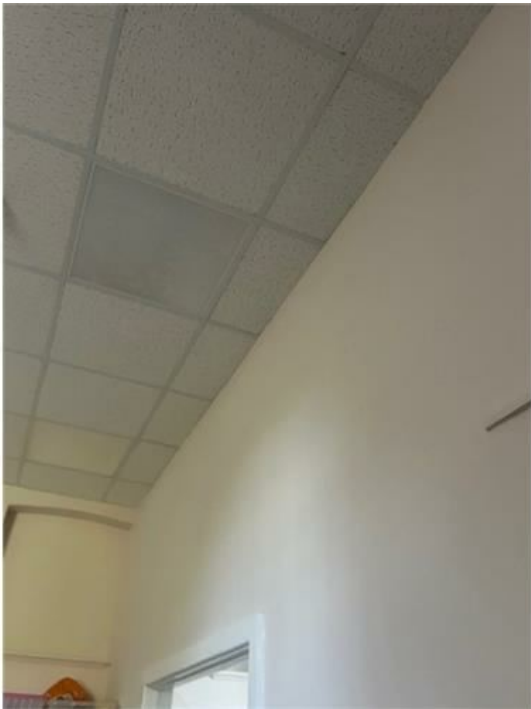
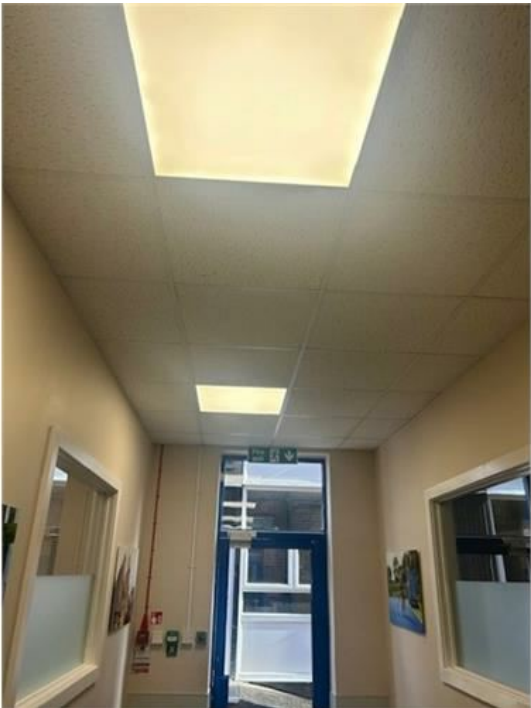
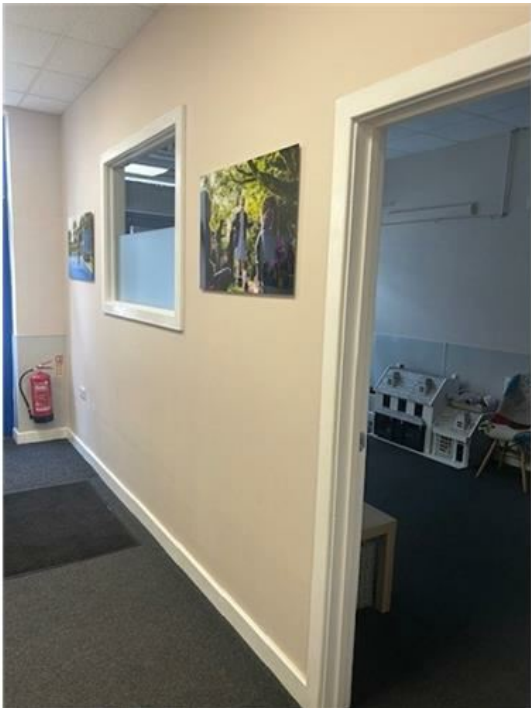
| Ref | Sub Section | Question | Non-conformity | Recommendation | Location | Who is responsible | By When |
|---|---|---|---|---|---|---|---|
| 13708102 | 4.0.A | Are the fire resisting and separating walls and floors in good condition? | The assessor was unable to ascertain that the materials installed within the 'new' walls seperating the SEND department and protected corridor are to the required and approved levels of fire resistance. Corridor partitions do not carry up through to the underside of the floor above. The glass within the wall does not seem to be fire rated. The doors within the wall are not FD30s type. | A further investigation will be required by a competent person (local building control) to ascertain the integrity of the materials used and that they will provide the correct level of fire resistance. If they do not have the correct level of fire resistance, then upgrading of the corridor will be required. | Walls within the protected corridor adjacent to the SEND department | Statutory requirement for the Client | 18/12/2025 |

Hazel Main door to SEND department.jpg

Hazel Main wall oppo SEND.jpg

Hazel Main wall to ceiling only.jpg

Hazel Main wall to ceiling only 2.jpg

Hazel Main walls from protected corridor.jpg

Hazel Main wall to SEND.jpg

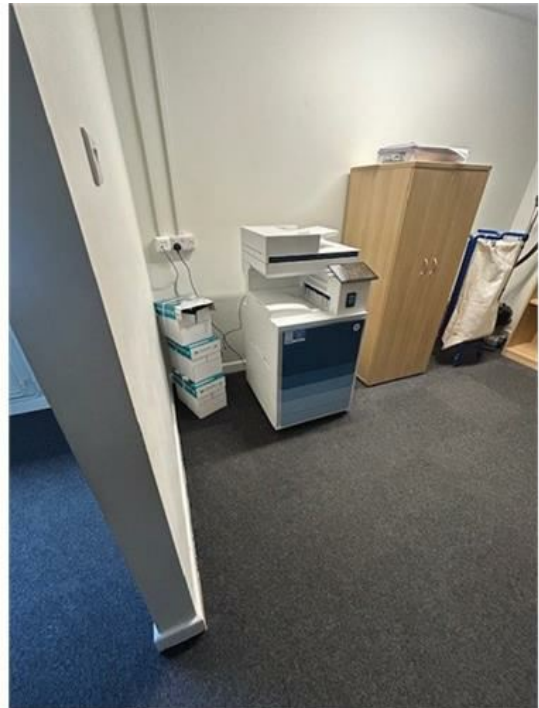
Hazel Ruth printer in corridor.jpg

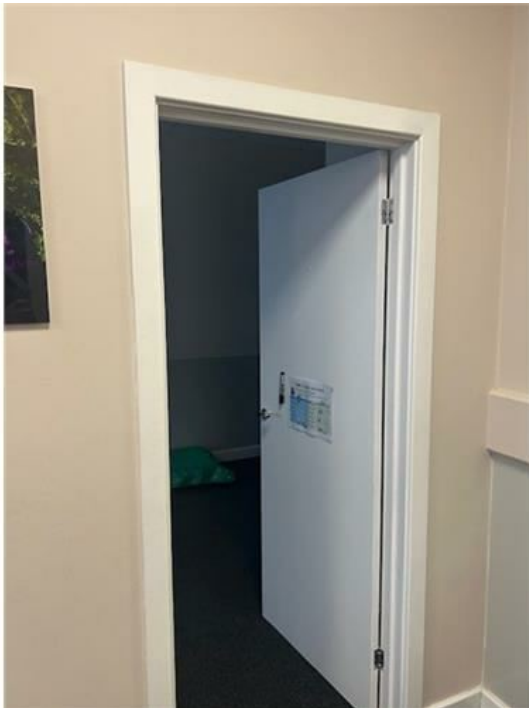
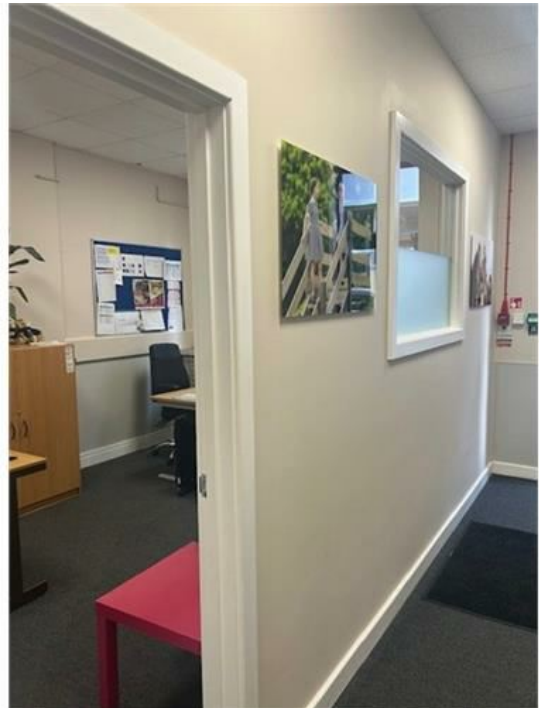
Hazel Main door to SEND department.jpg

Hazel Main wall oppo SEND.jpg

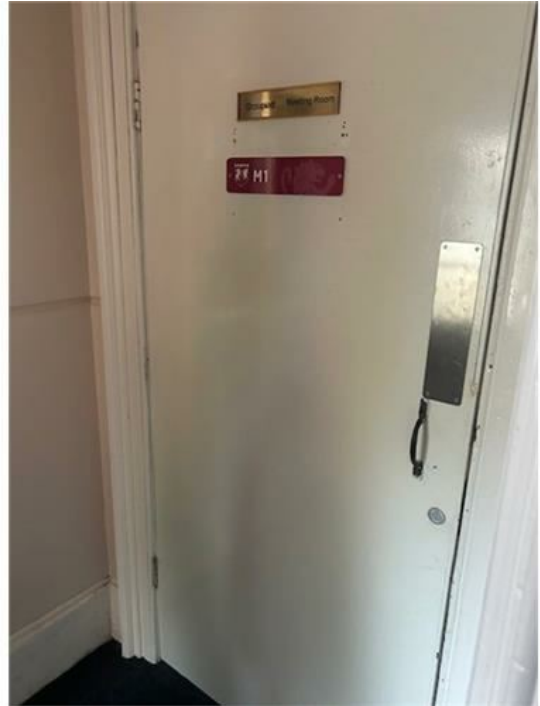
Hazel Main FD no closer 2 hinges no sign.jpg

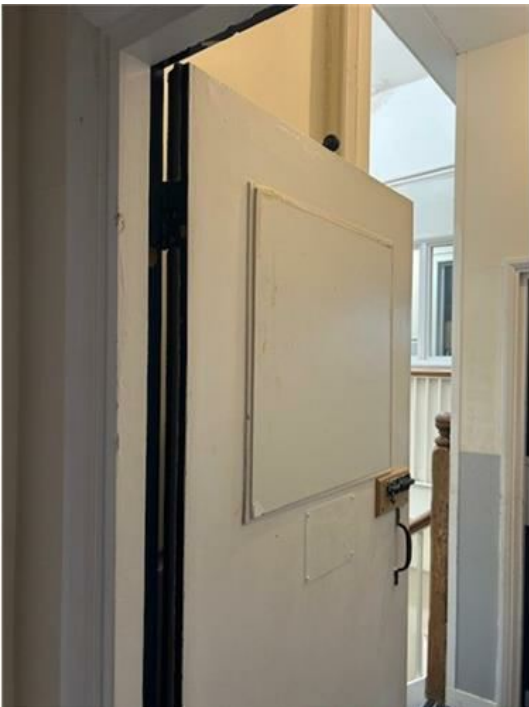
Hazel Main FD onto protected staircase.jpg

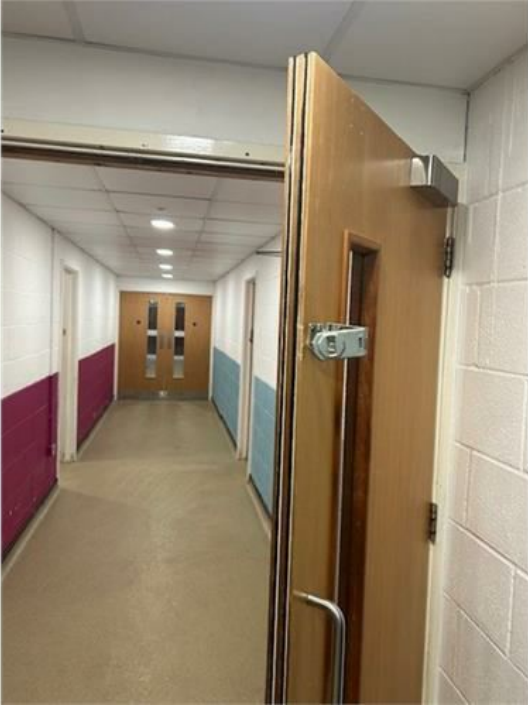
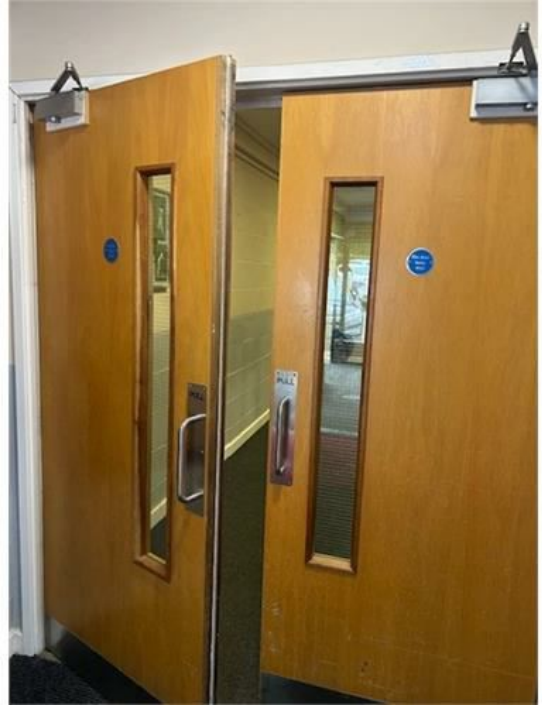
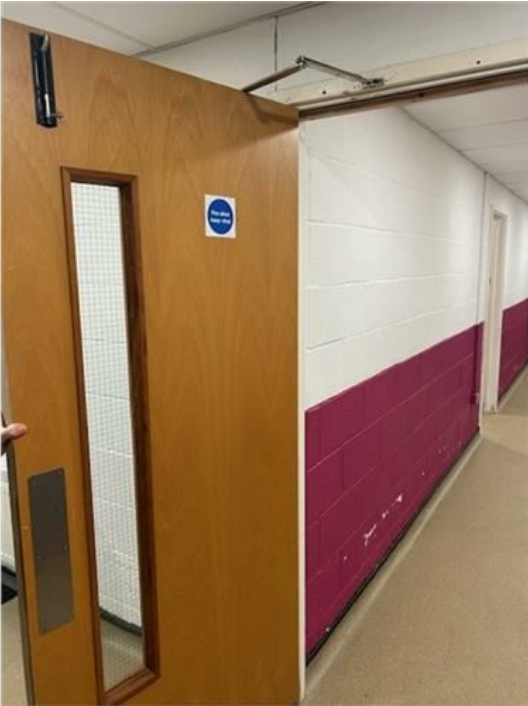
Hazel sports door broken.jpg

Hazel sports door not closing.jpg

Hazel sports door broken 2.jpg

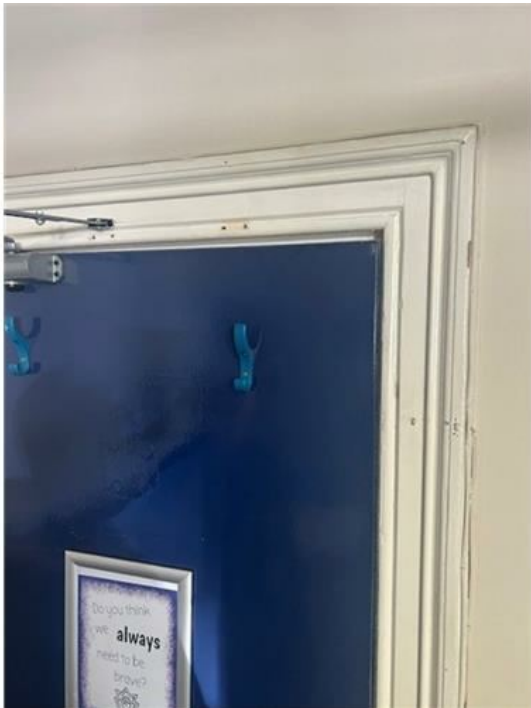
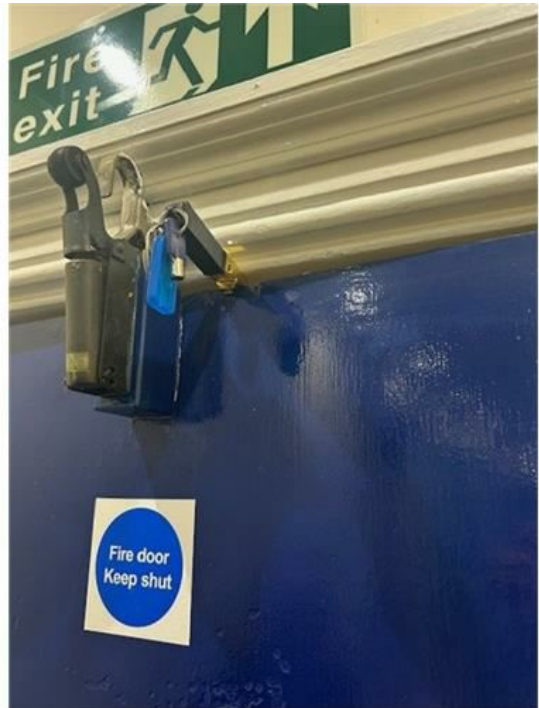
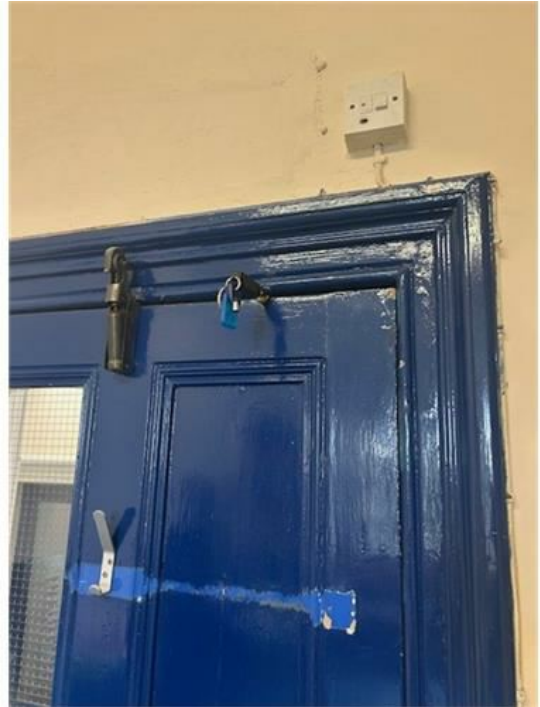
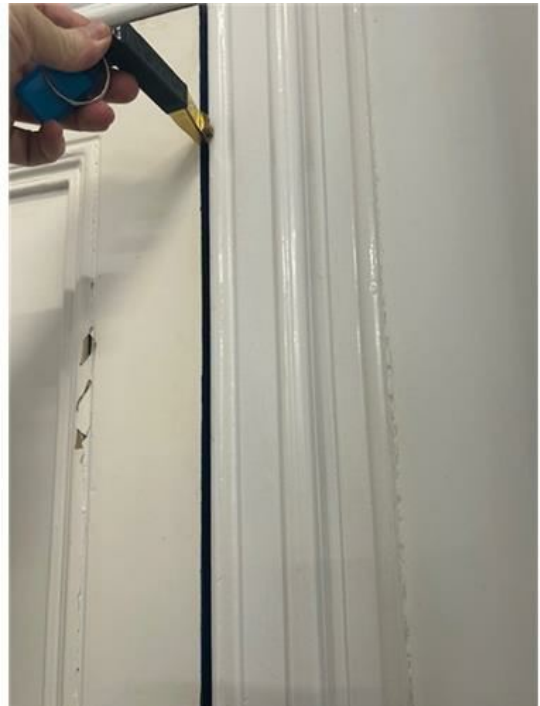
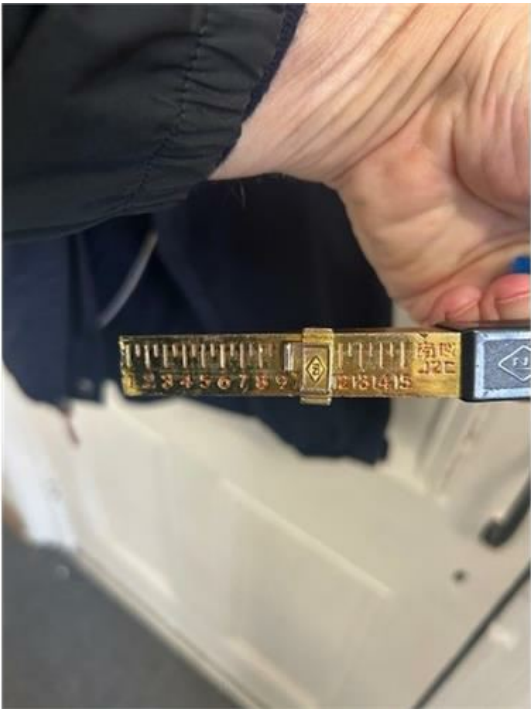
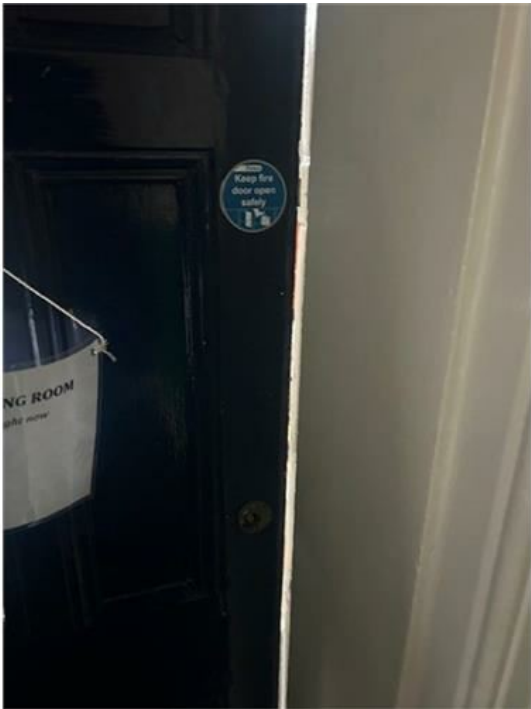
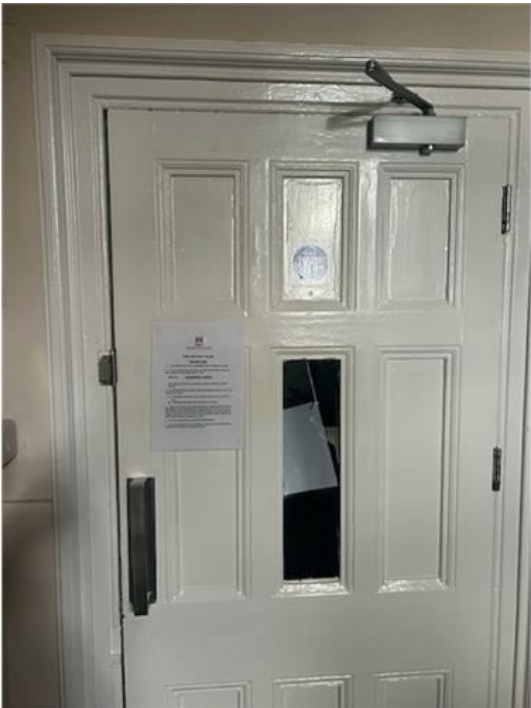
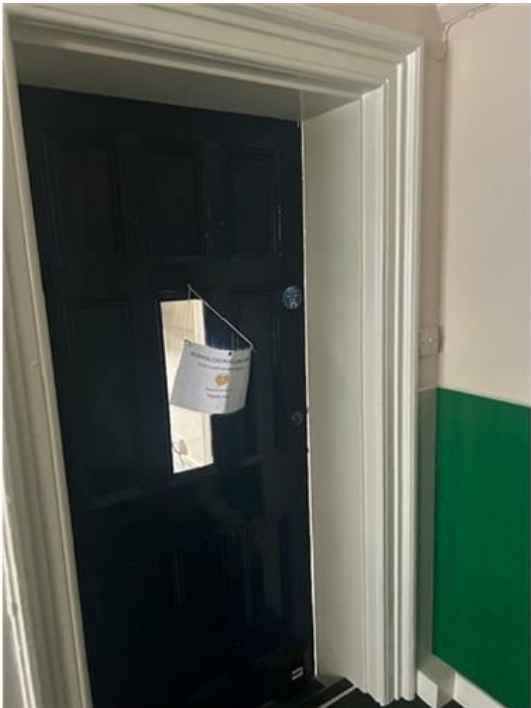
| Ref | Sub Section | Question | Non-conformity | Recommendation | Location | Who is responsible | By When |
|---|---|---|---|---|---|---|---|
| 13708107 | 5.0.X | Do the fire resisting door sets meet the appropriate standard? | The fire doors have a large gap between the doors and the frame which may prevent the intumescent seals being effective. | The doors should be adjusted to ensure that there is no more than a 3mm gap between the hinge edge, leading edge and the top of the door frame. In some cases the doors will need to be replaced or have additional pieces added. This can be carried out by a qualified Fire Door specialist. | Multiple doors around the site, in particular the main building | Statutory requirement of the Client | 18/12/2025 |

Hazel Main excessive door gap.jpg

Hazel Main excessive door gap 2.jpg

Hazel Main excessive door gap 4.jpg

Hazel Main excessive door gap 6.jpg

Hazel Main excessive door gap 7.jpg

Hazel Main excessive door gap SEND.jpg

Hazel Main excessive door gap SEND 2.jpg

Hazel Main excessive door gap SEND 3.jpg

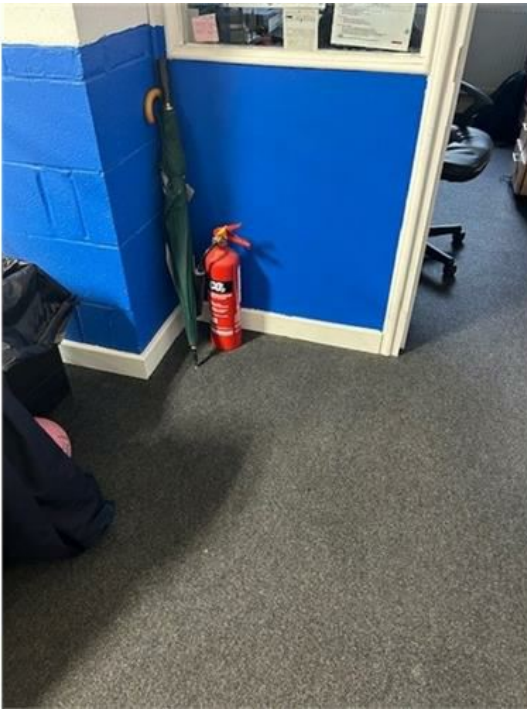
Hazel Sports incorrect position of extinguisher.jpg

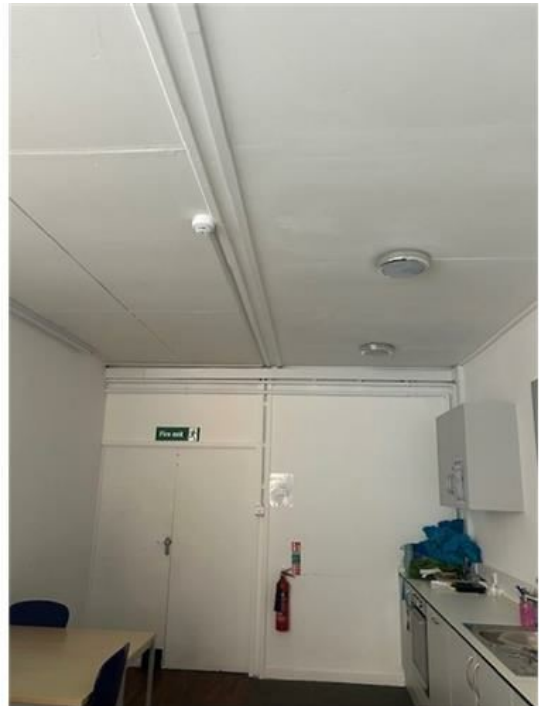
Hazel Dining tech room no Fire Blanket 2.jpg

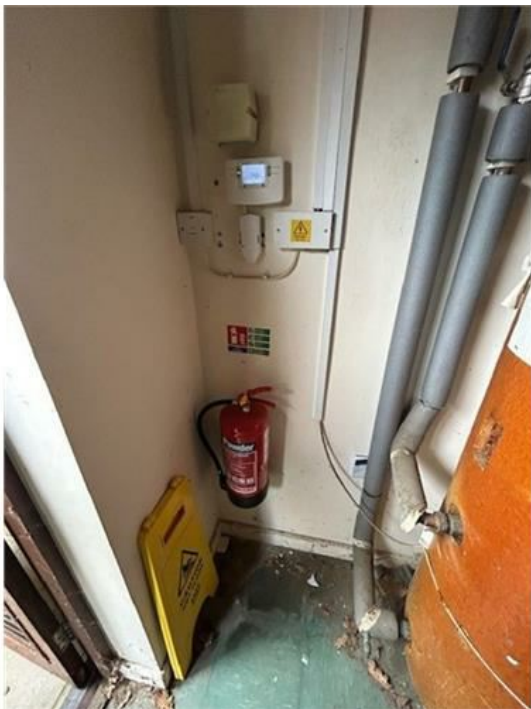
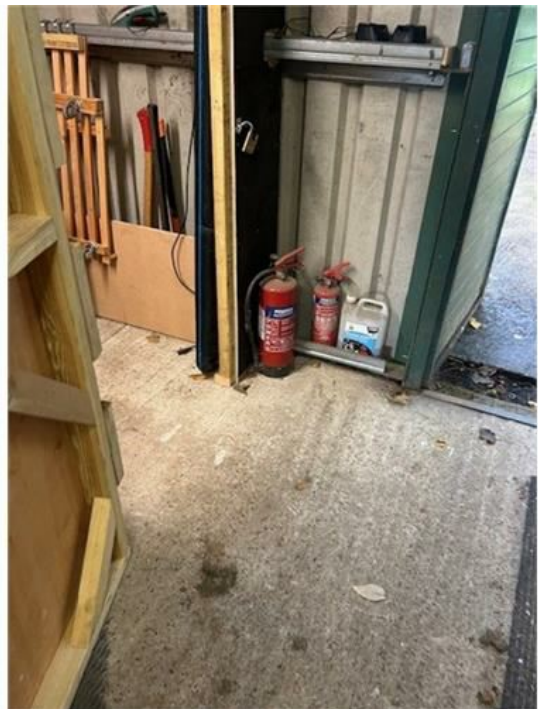
| Ref | Sub Section | Question | Non-conformity | Recommendation | Location | Who is responsible | By When |
|---|---|---|---|---|---|---|---|
| 13708117 | 6.0.NR-50-202-8 | Are there sufficient quantities of portable fire-fighting equipment provided, correctly sited and adequately maintained? | There are some dry powder fire extinguishers in place in the premises. The discharge of a powder extinguisher within buildings can cause a sudden reduction of visibility and can also impair breathing, which could temporarily jeopardize escape, rescue or other emergency action. For this reason, powder extinguishers should generally not be specified for use indoors, unless mitigated by a health and safety risk assessment. | It is recommended that the dry powder fire extinguisher/s are replaced with a suitable alternative extinguisher/s appropriate to the fire hazards present. If, due to the H&S assessment specifying that the Dry Powder extinguisher is to stay in place. Then training should be given to any person who is tasked to operate in the area. | Plant rooms (enclosed spaces) and groundsman hut. | Recommendation to the Client | 18/12/2025 |

Hazel Dry Powder.jpg

Hazel Dry Powder 2.jpg

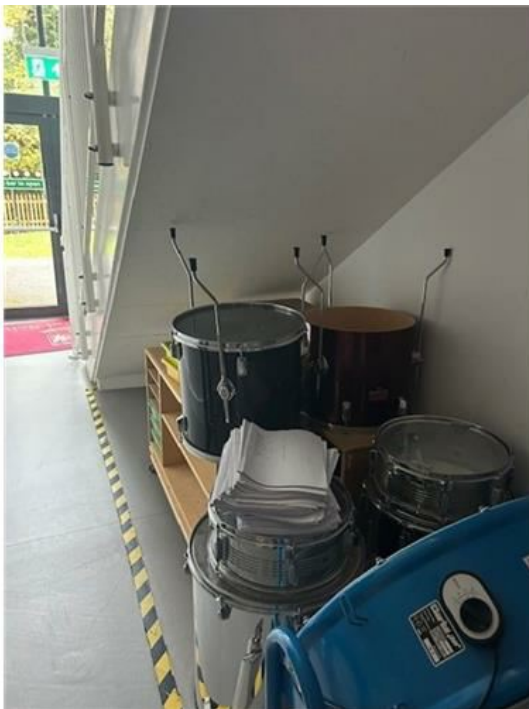
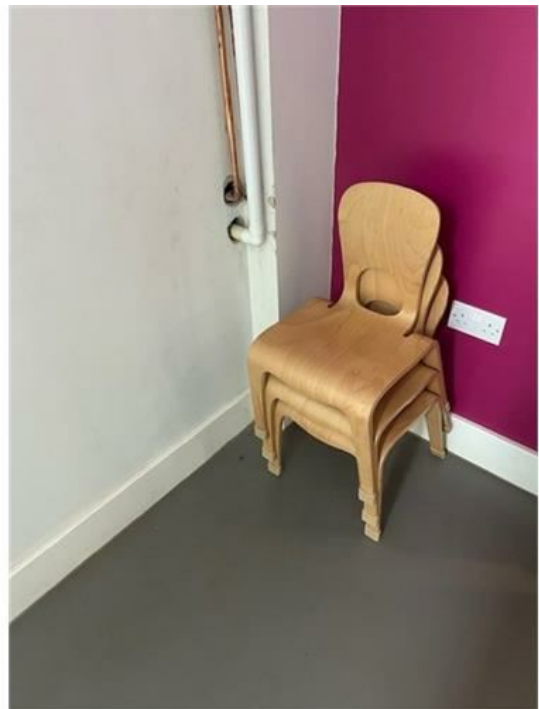
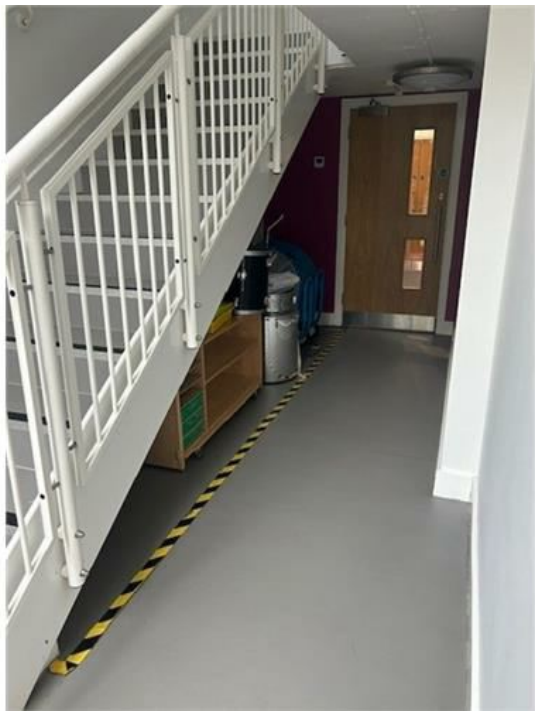
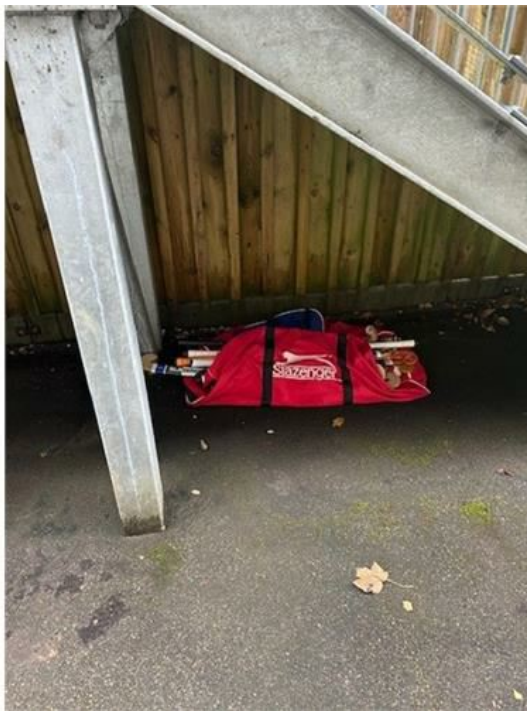
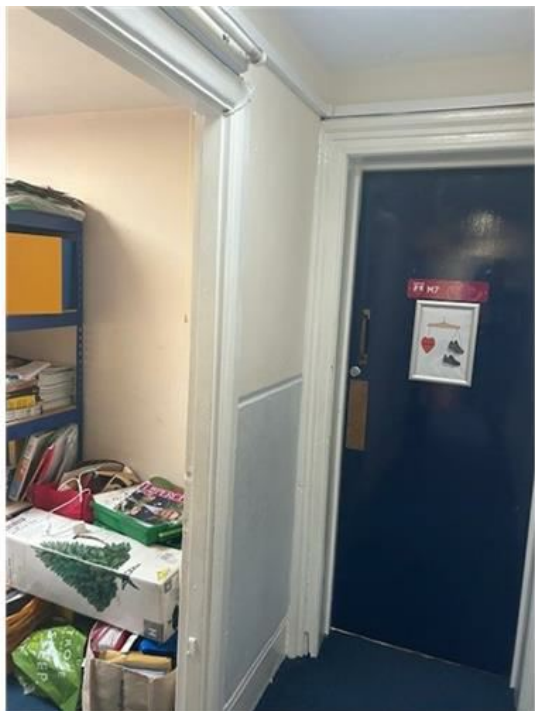
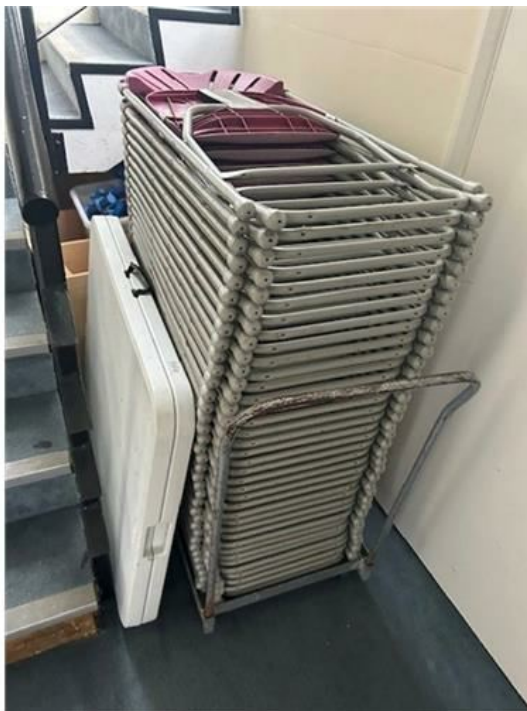
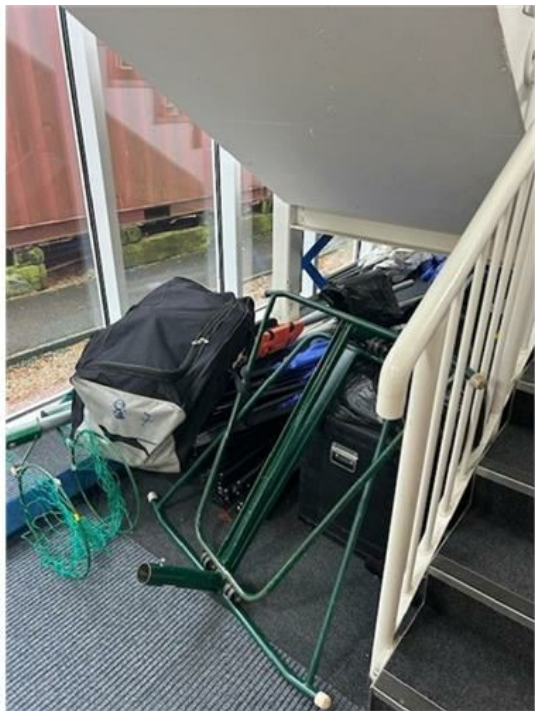
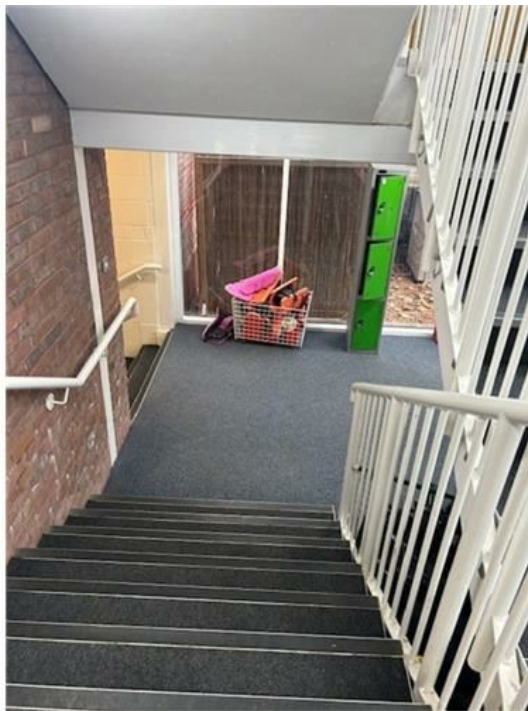
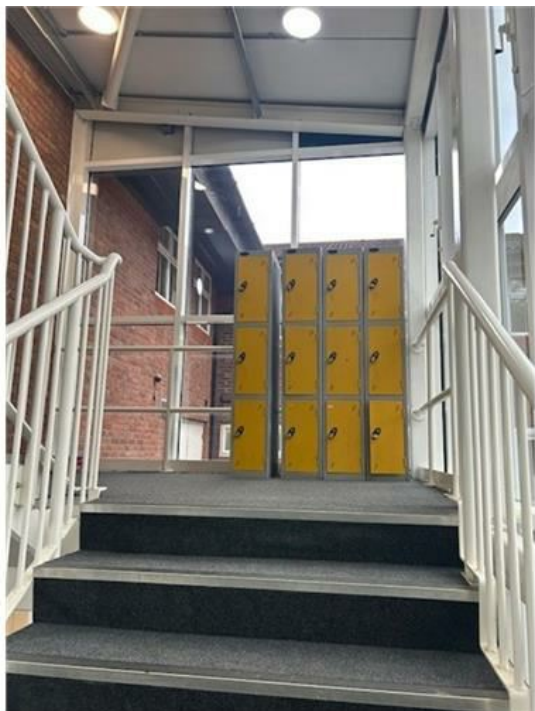
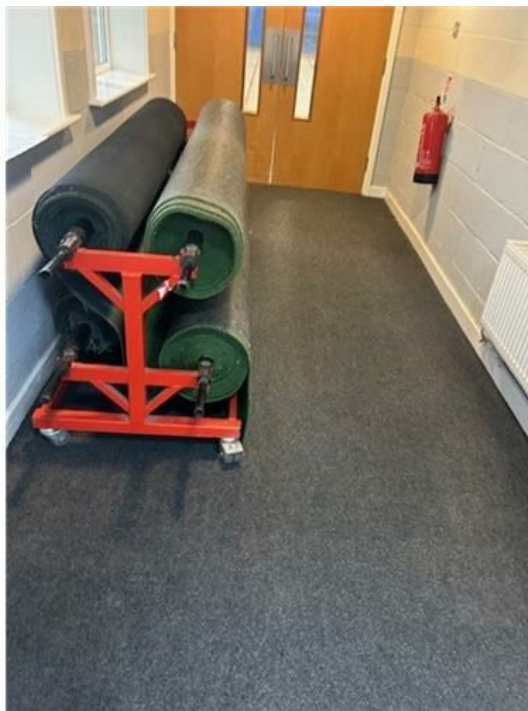
Hazel Bailey Combustibles in protected staircase.jpg

Hazel Bailey Combustible chairs in protected staircase 2.jpg

Hazel Bailey Combustibles in protected staircase 2.jpg

Hazel Bailey combustibles left under escape stairs.jpg

Hazel Main combustibles on escape route.jpg

Hazel Theatre chairs on protected staircase.jpg

Hazel sports storage in staircase 1.jpg

Hazel sports storage in staircase 2.jpg

Hazel sports storage in staircase 3.jpg

Hazel sports storage in staircase 4.jpg

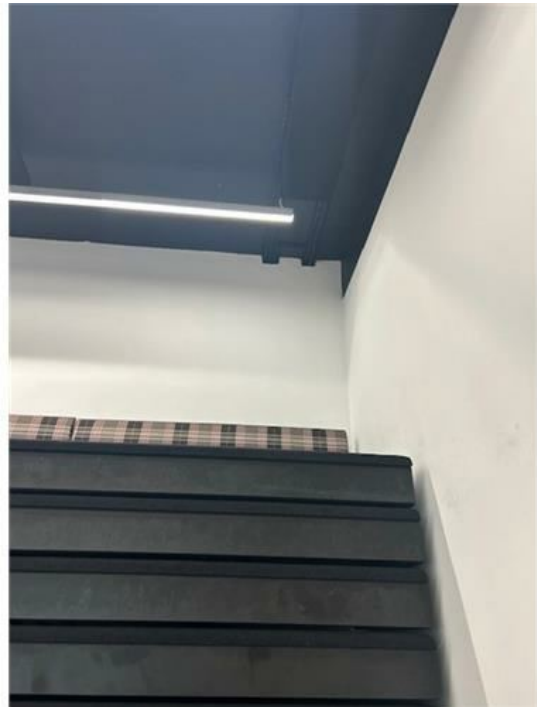
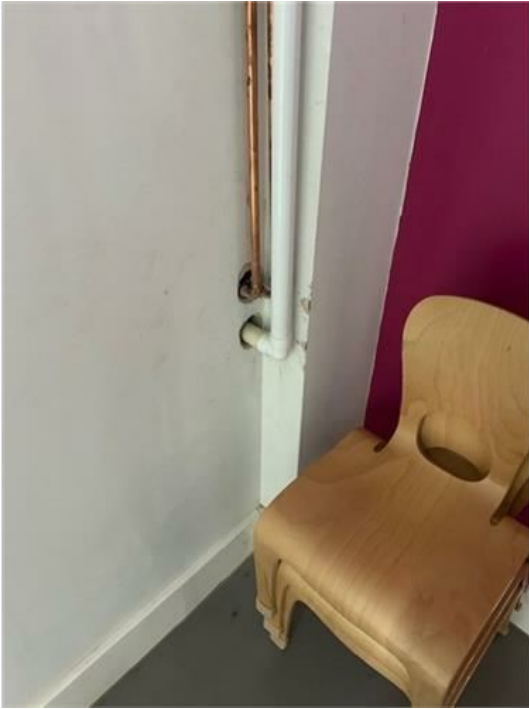
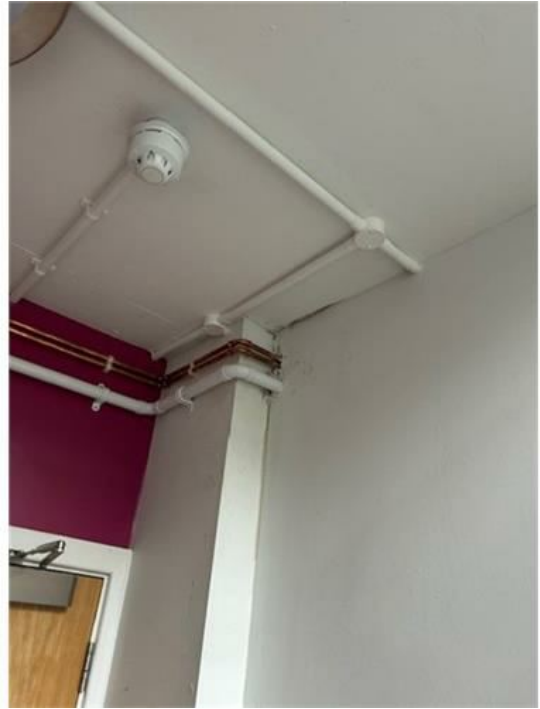
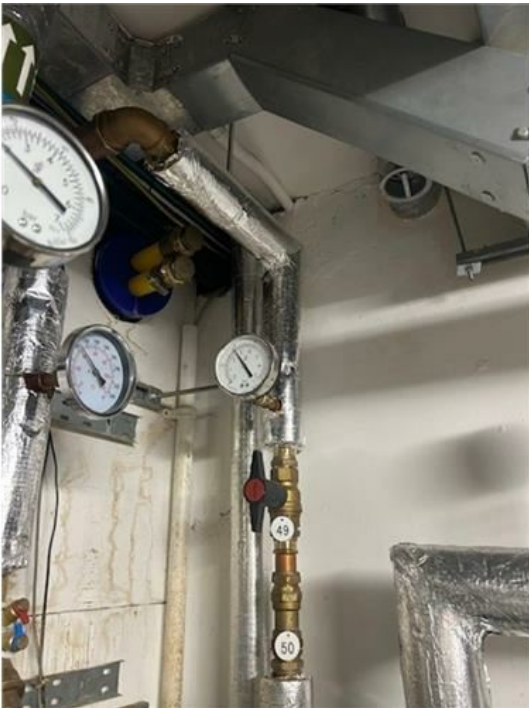
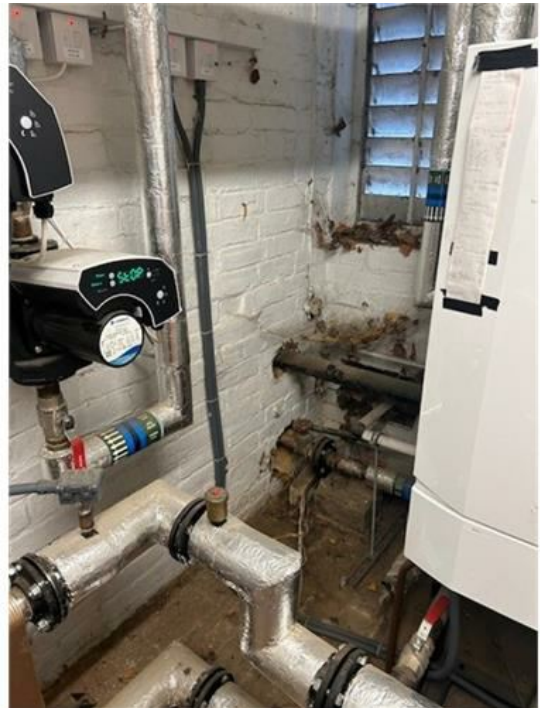
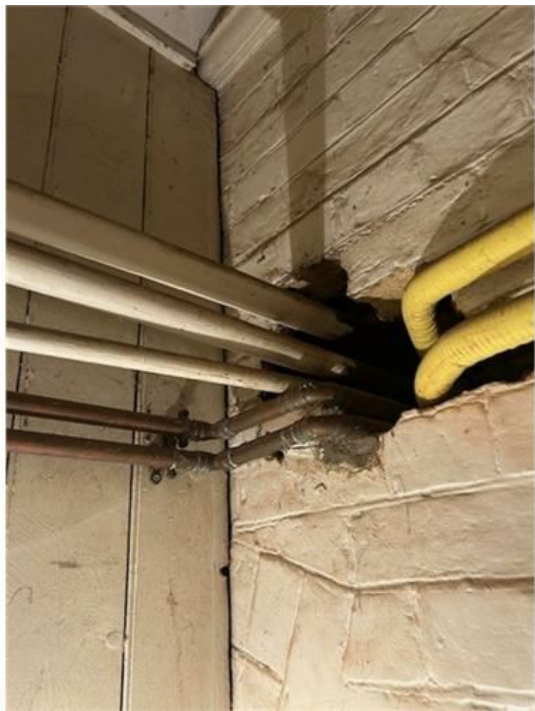
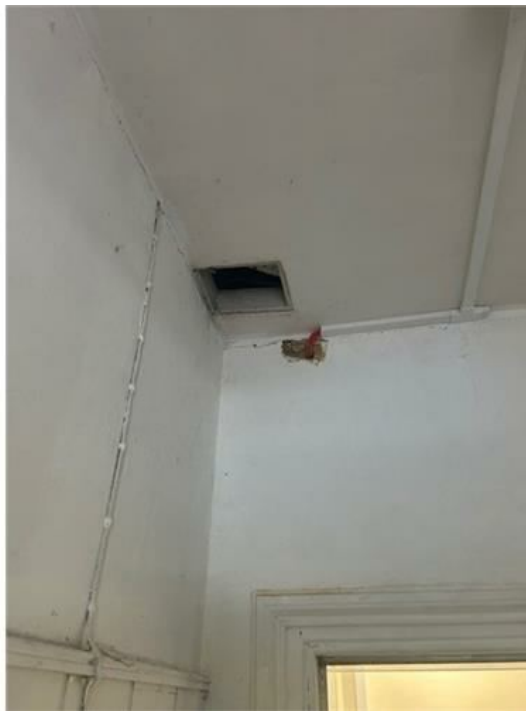
| Sub Section | Question | Answer | Action Plan | Status |
|---|---|---|---|---|
| <b>01 - Structural Elements</b> | Are the fire resisting and separating walls and floors in good condition? | Fire stopping between compartments is missing and/or poorly installed. 1- Bailey Plant Room, protected staircase and Bawtree Room 2- Main Block, Plant room and staircase to maintenance office. 3- Main Block Laundry room. | <a href="#">E</a> | <b>Non_Compliant</b> |

Hazel Bailey Holes in Bawtree wall 2.jpg

Hazel Bailey Holes in protected staircase.jpg

Hazel Bailey Holes in protected staircase 2.jpg

Hazel Bailey plant room holes.jpg

Hazel Main no Fire stopping.jpg

Hazel Main no Fire stopping 2.jpg

Hazel Main hole in laundry room ceiling.jpg

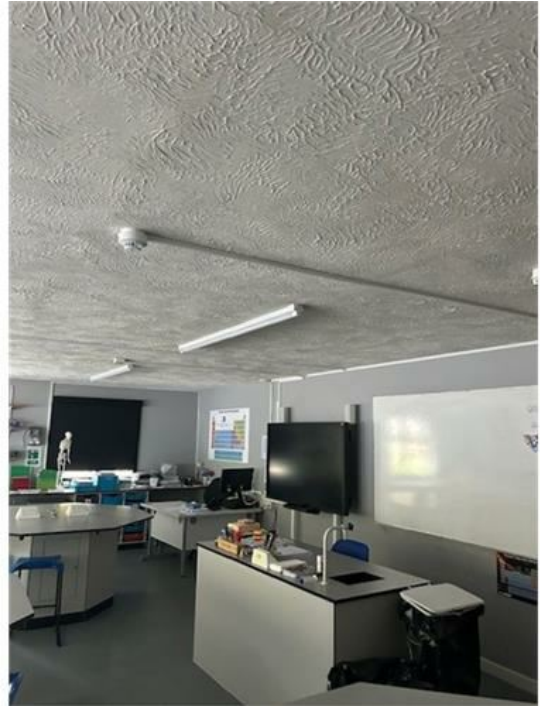
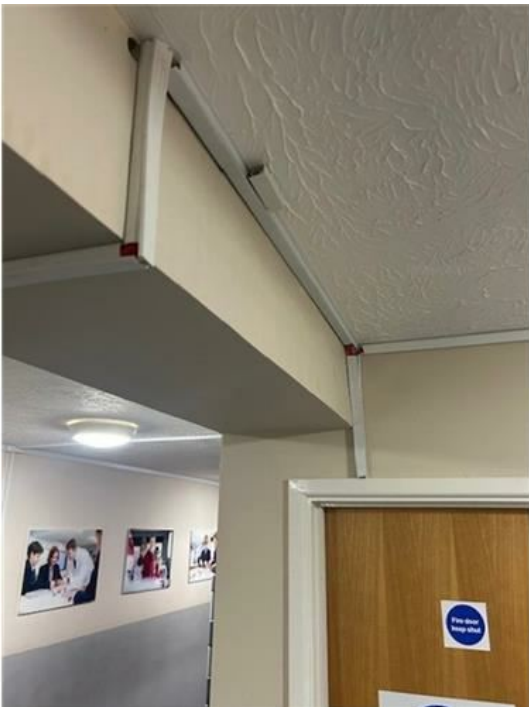
| Sub Section | Question | Answer | Action Plan | Status |
|---|---|---|---|---|
| <b>02 - Firefighter Safety</b> | Have all reasonable measures and arrangements been made to safeguard firefighting personnel in a fire situation? | A large number of overhead cables are being supported by plastic cable-ties or within conduit that has been fixed to the ceiling in Willow block. This can lead to fire-fighter fatalities as they fail and cables drop in a fire situation. | <a href="#">E</a> | <b>Non_Compliant</b> |

Hazel willow conduit.jpg

Hazel willow conduit 2.jpg
