# Fire Risk Assessment

Hazelwood School

21 Oct 2025

Ian Meares AIFireE

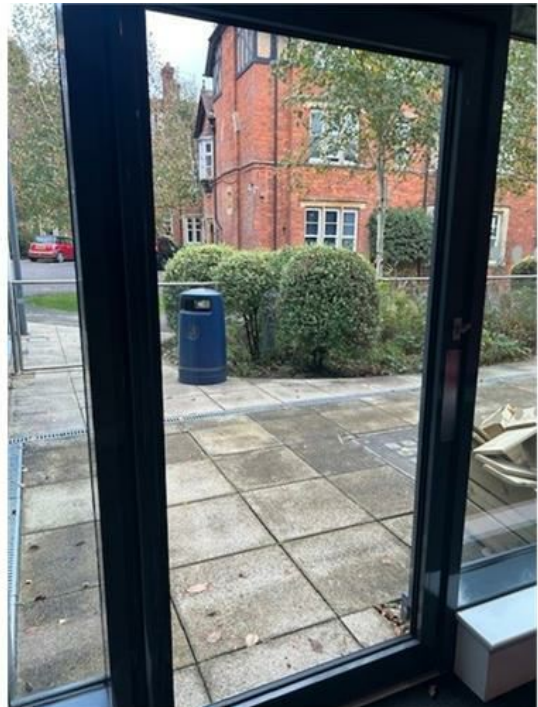
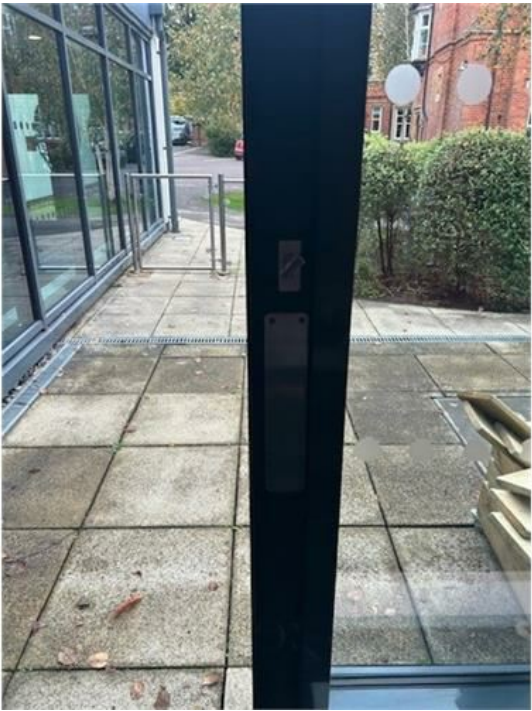
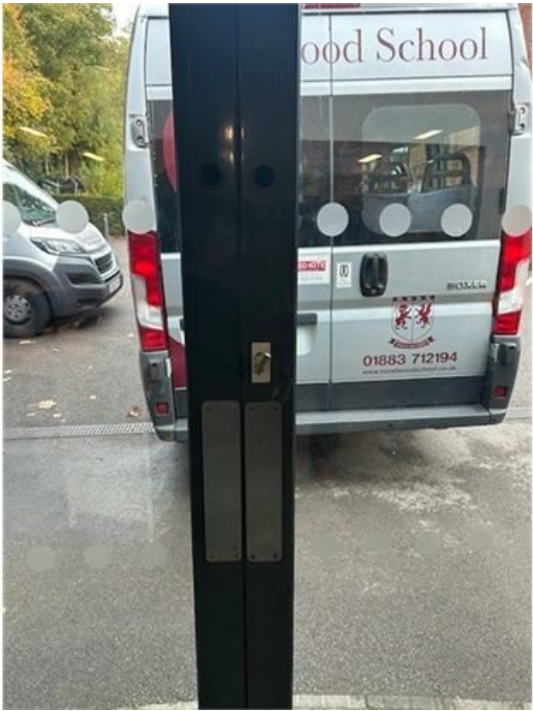
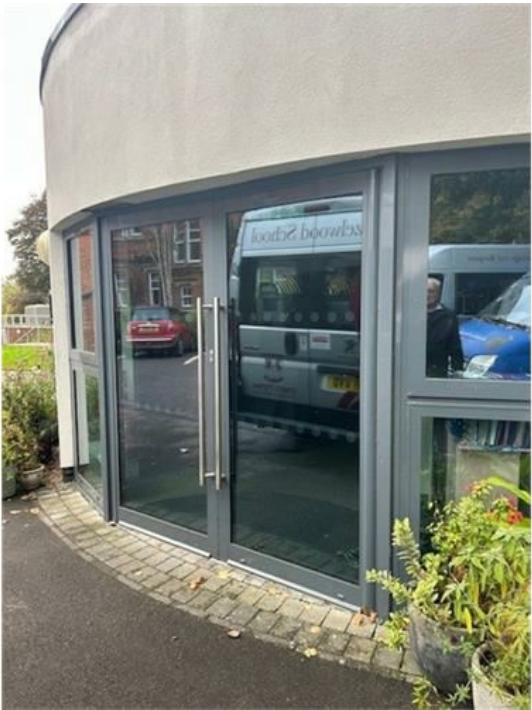
Hazel Bailey No FEKC sign on door.jpg

Hazel Bailey No FEKC sign on door 3.jpg

Hazel Bailey No FEKC sign on door 4.jpg

Hazel Bailey No FEKC sign on door 5 library.jpg

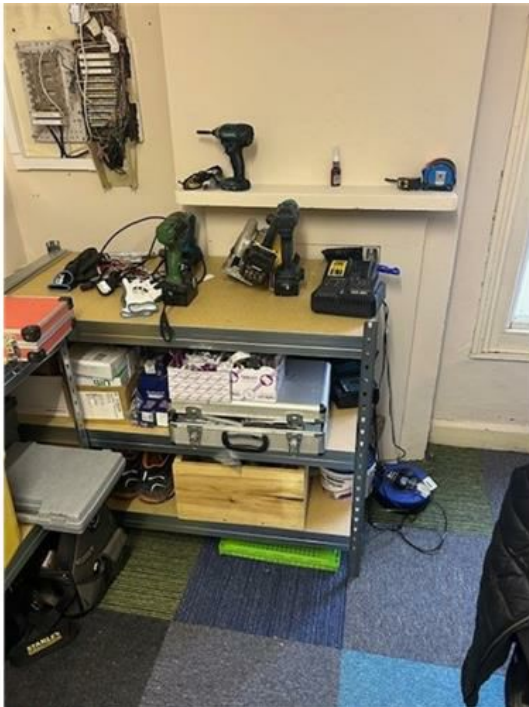
Hazel main battery charging.jpg

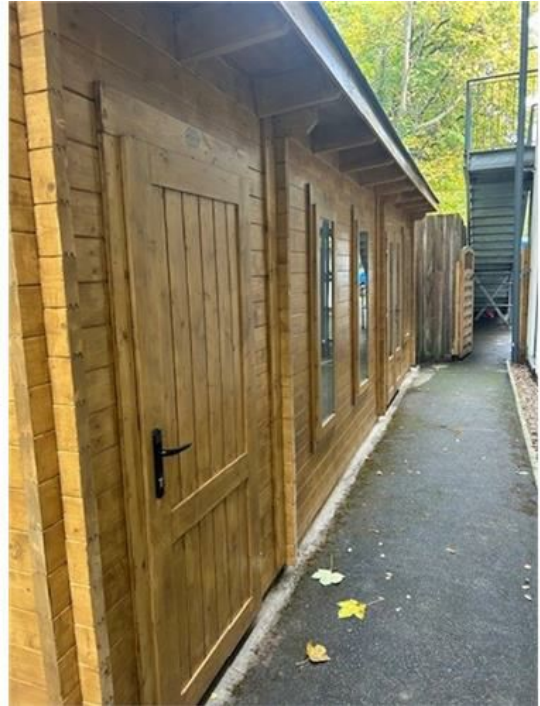
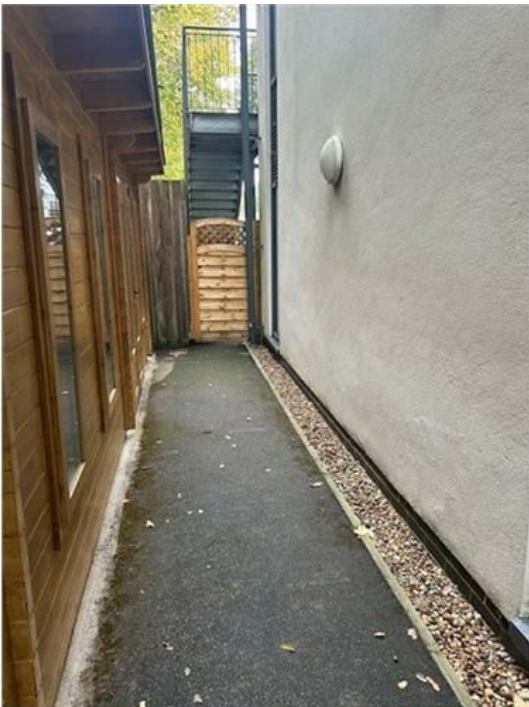
The timber Wellbeing Lodge has neither any fire detection nor a sounder. Due to its close proximity to the Bailey building, it is recommended that both are added to the lodge.

Hazel Bailey Lodge 2.jpg

Hazel Bailey Lodge 3 no directional signage.jpg

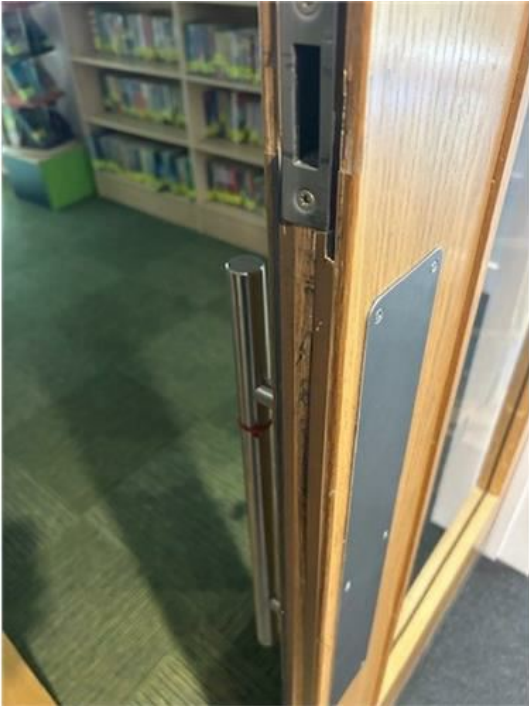
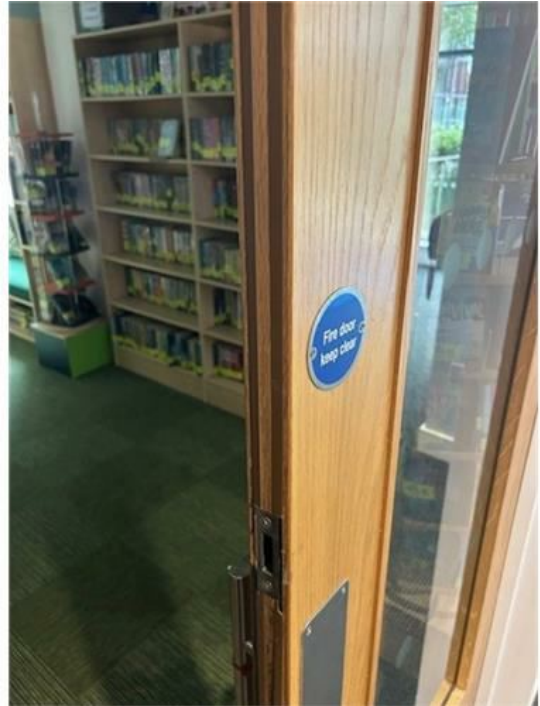
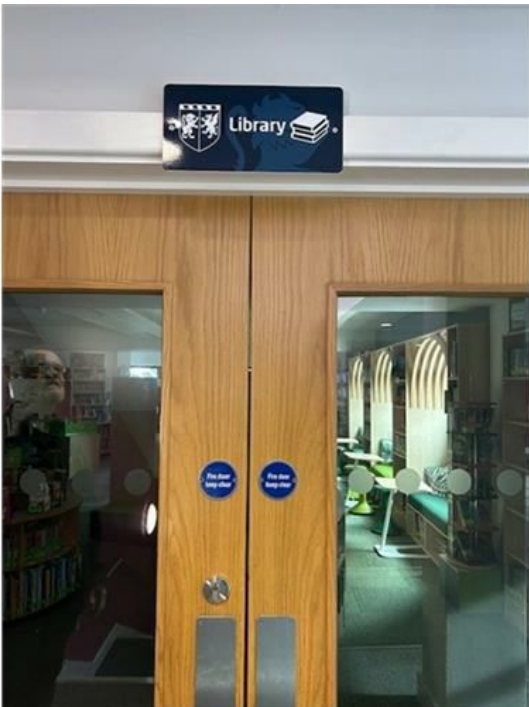
| <b>11 - Fire-resisting doors</b> | Do the fire resisting door sets meet the appropriate standard? | The intumescent cold smoke seals installed to prevent the spread of smoke and fire between compartments are missing. This has caused a large gap between the doors. | <a href="#">U</a> | <b>Non_Compliant</b> |

Hazel Bailey smoke seal missing - damaged Library.jpg

Hazel Bailey smoke seal missing - damaged Library 2.jpg

Hazel Bailey smoke seal missing - damaged Library 3.jpg

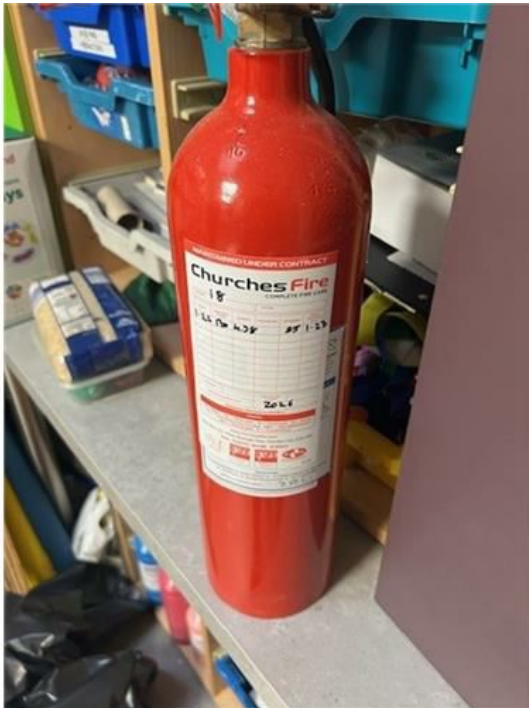
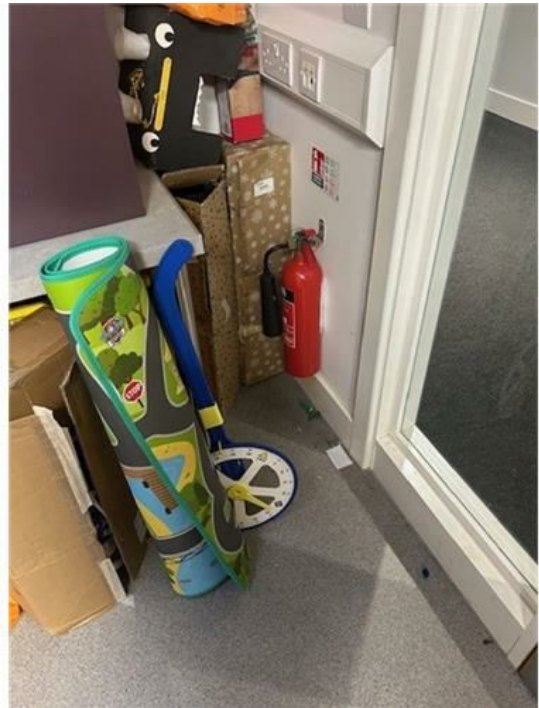
Hazel Bailey CO2 OOD.jpg

Hazel Bailey CO2 OOD 2.jpg
