# Fire Risk Assessment

Hazelwood School

21 Oct 2025

Ian Meares AIFireE

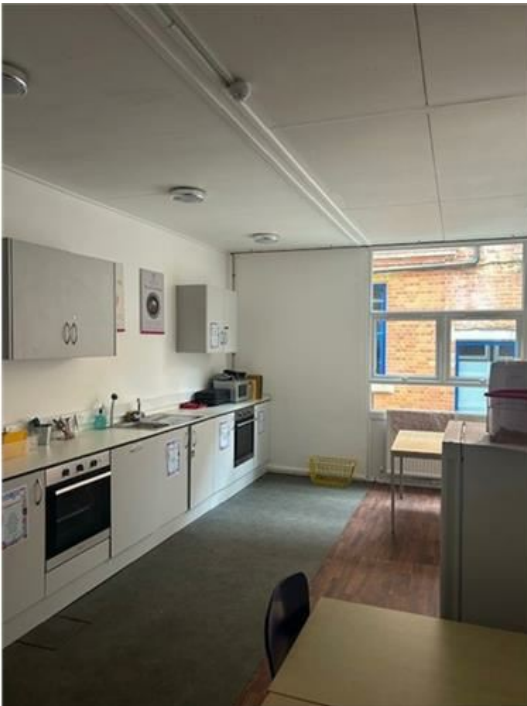
Hazel Dining tech room no Fire Blanket.jpg

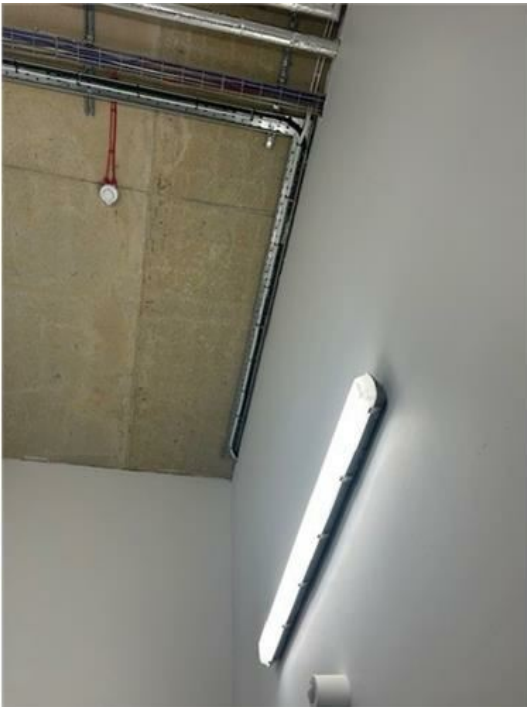
Hazel Bailey Holes in Bawtree wall.jpg
