# Fire Risk Assessment

Hazelwood School

21 Oct 2025

Ian Meares AIFireE

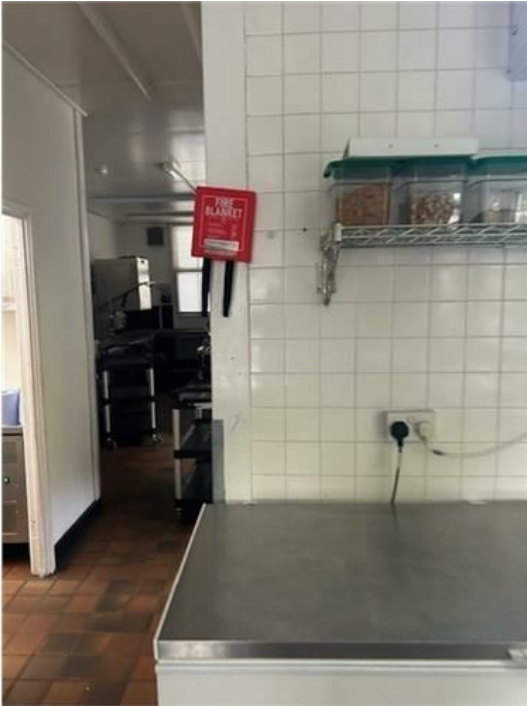
Hazel Dining no FB sign.jpg

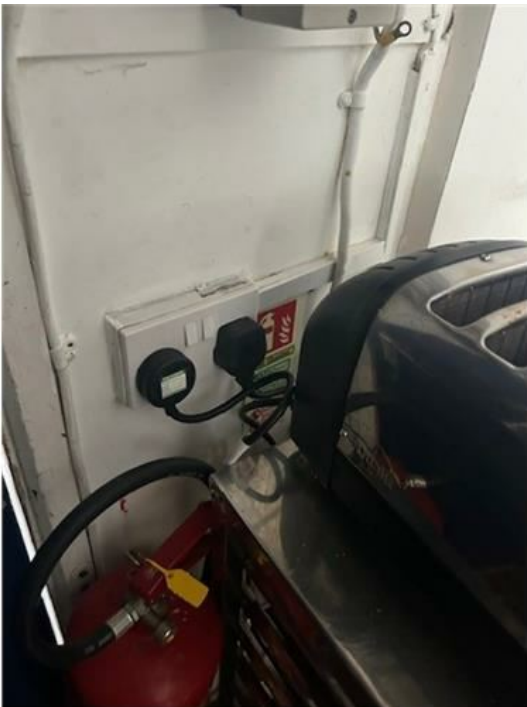
Hazel Dining extinguisher and sign obstructed 2.jpg

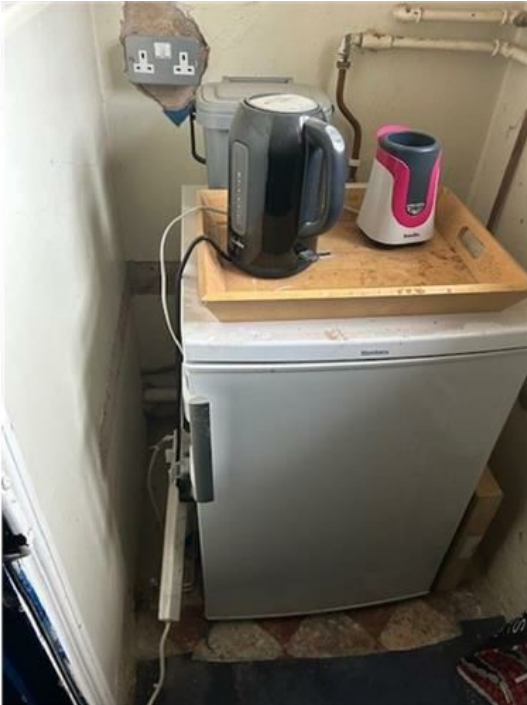
Hazel main poor use of extension cable.jpg

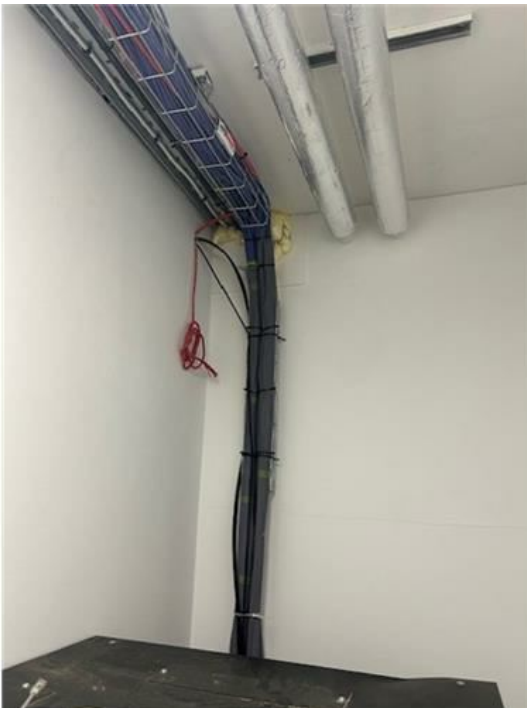
Hazel Bailey incorrect fire stopping.jpg

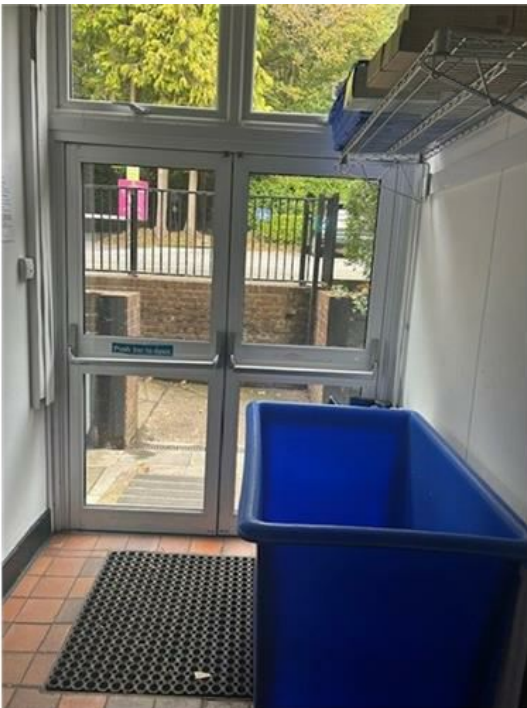
Hazel Dining obstruction near fire exit.jpg

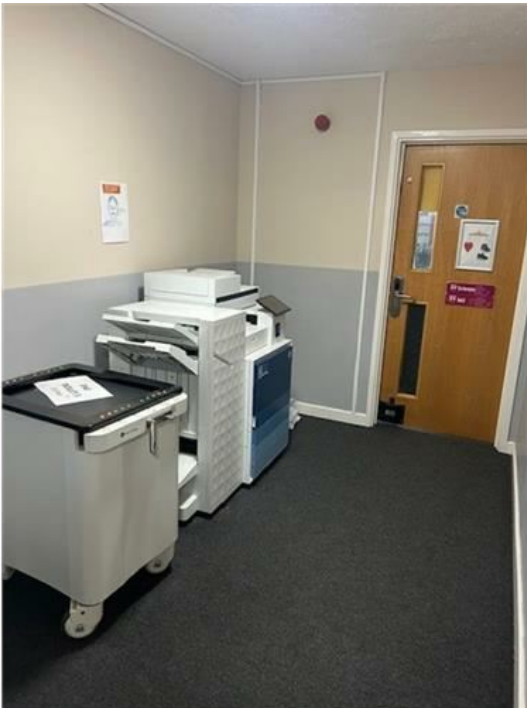
Hazel willow printer in corridor.jpg

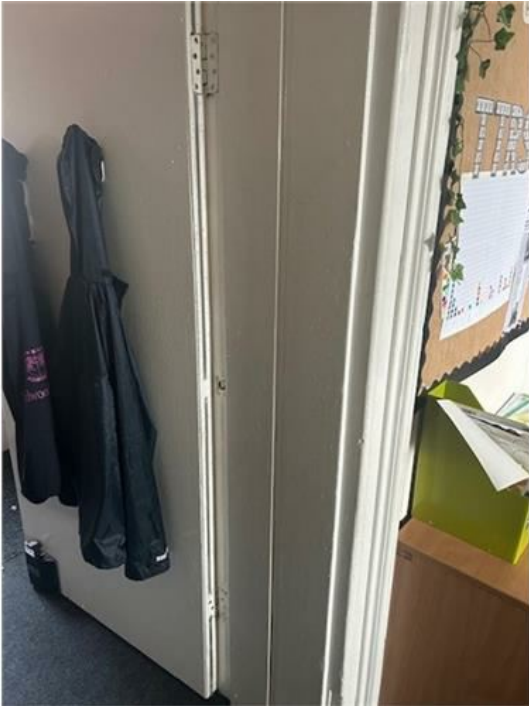
Hazel main FD no closer - 2 hinges.jpg

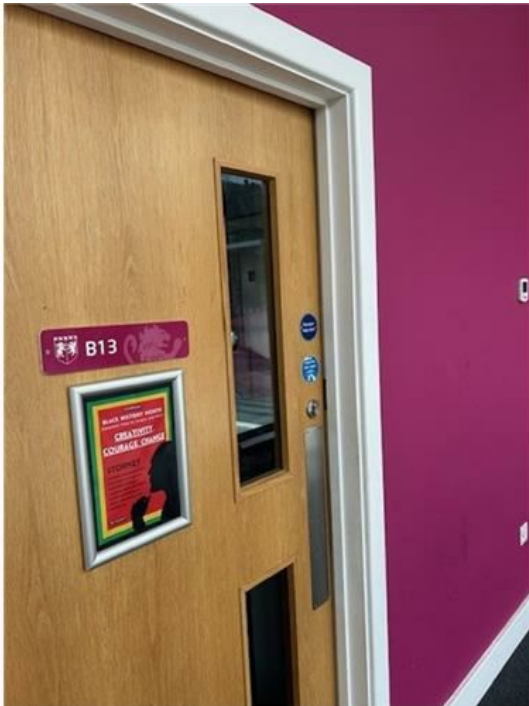
Hazel Bailey door not closing properly.jpg

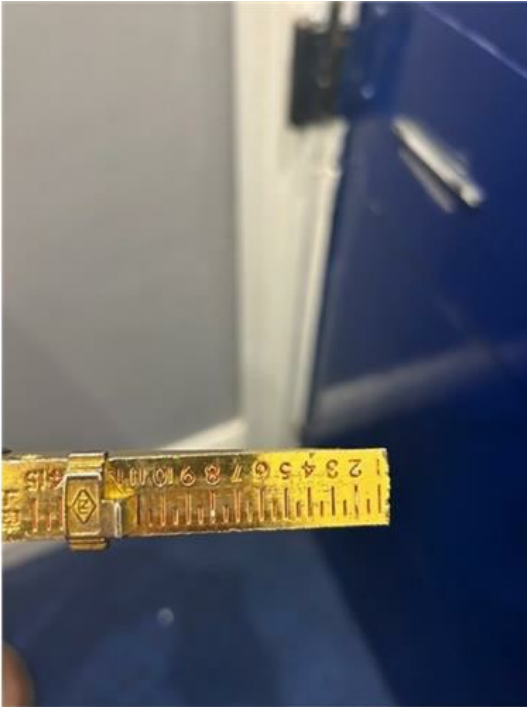
Hazel Main excessive door gap 3.jpg

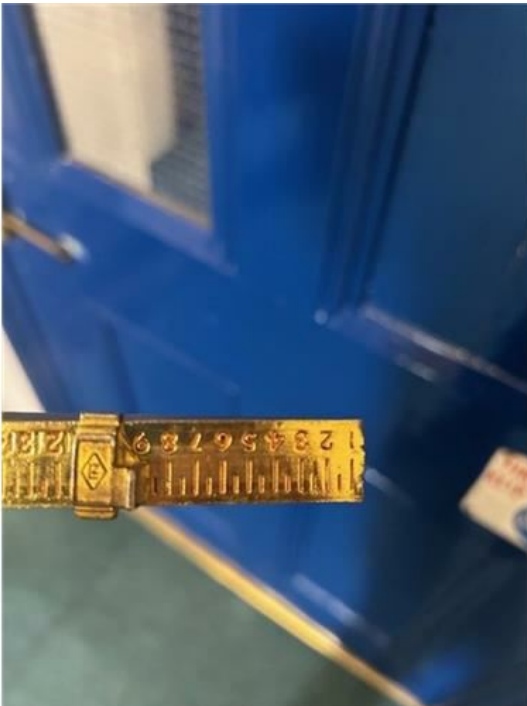
Hazel Main excessive door gap 5.jpg

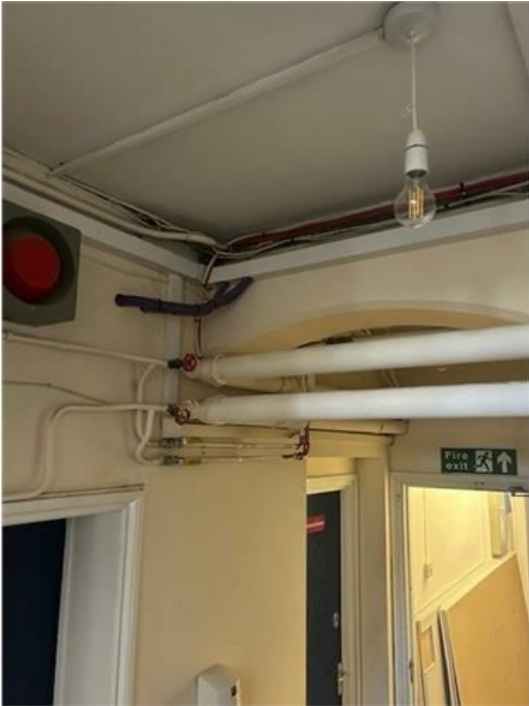
Hazel Main Cabel management.jpg

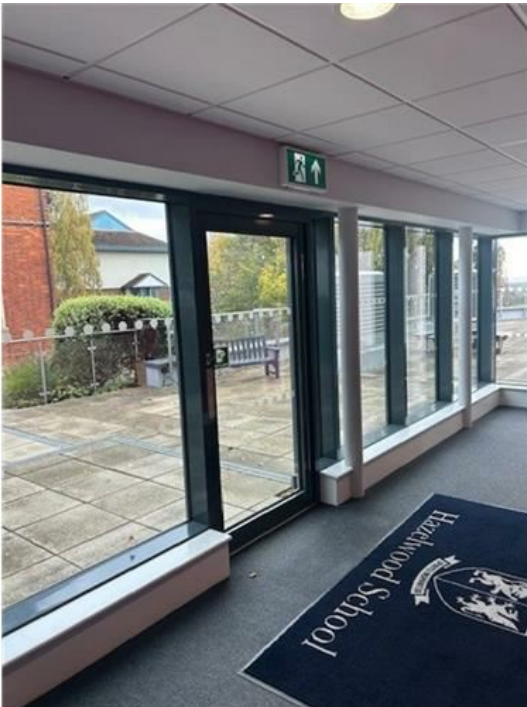
Hazel Bailey No FEKC sign on door 2.jpg

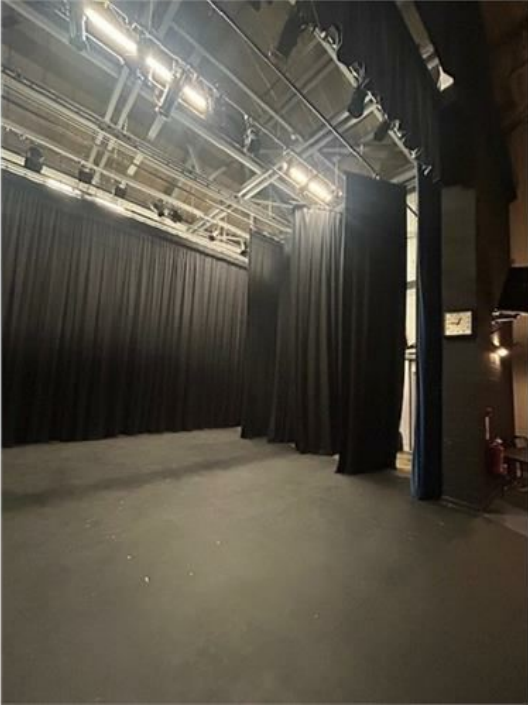
Hazel theatre curtains not FP.jpg

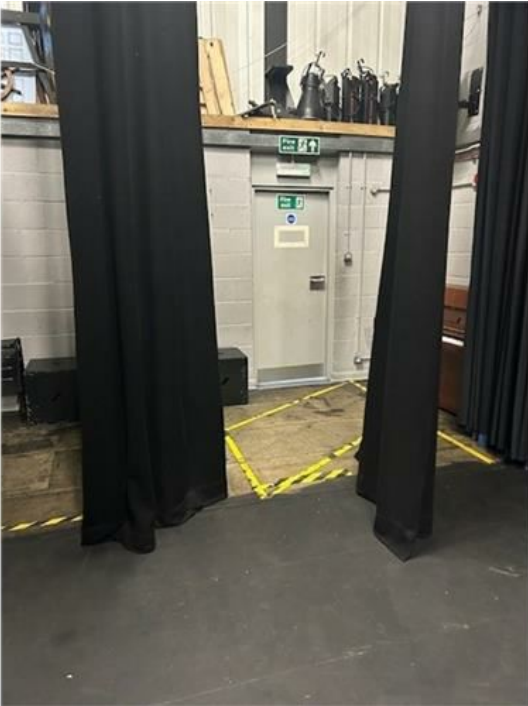
Hazel theatre curtains not FP 3.jpg

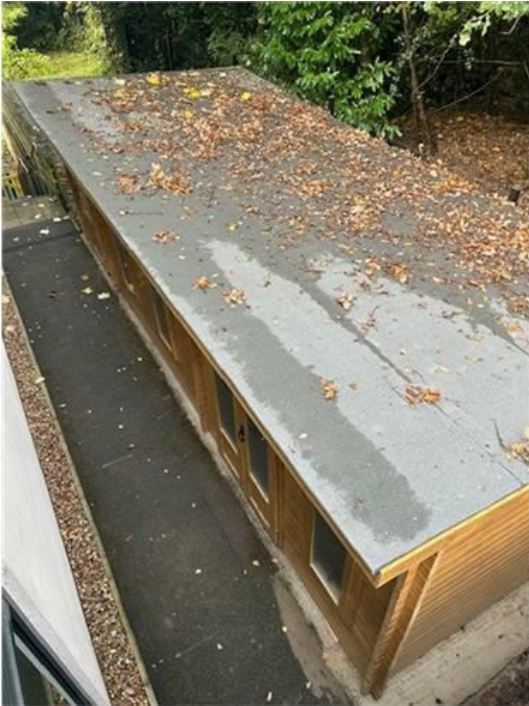
The timber Wellbeing Lodge has neither any fire detection nor a sounder. Due to its close proximity to the Bailey building, it is recommended that both are added to the lodge.

Hazel Bailey Lodge.jpg
